Hazel Avenue Infrastructure Project

Tree Impact Inventory

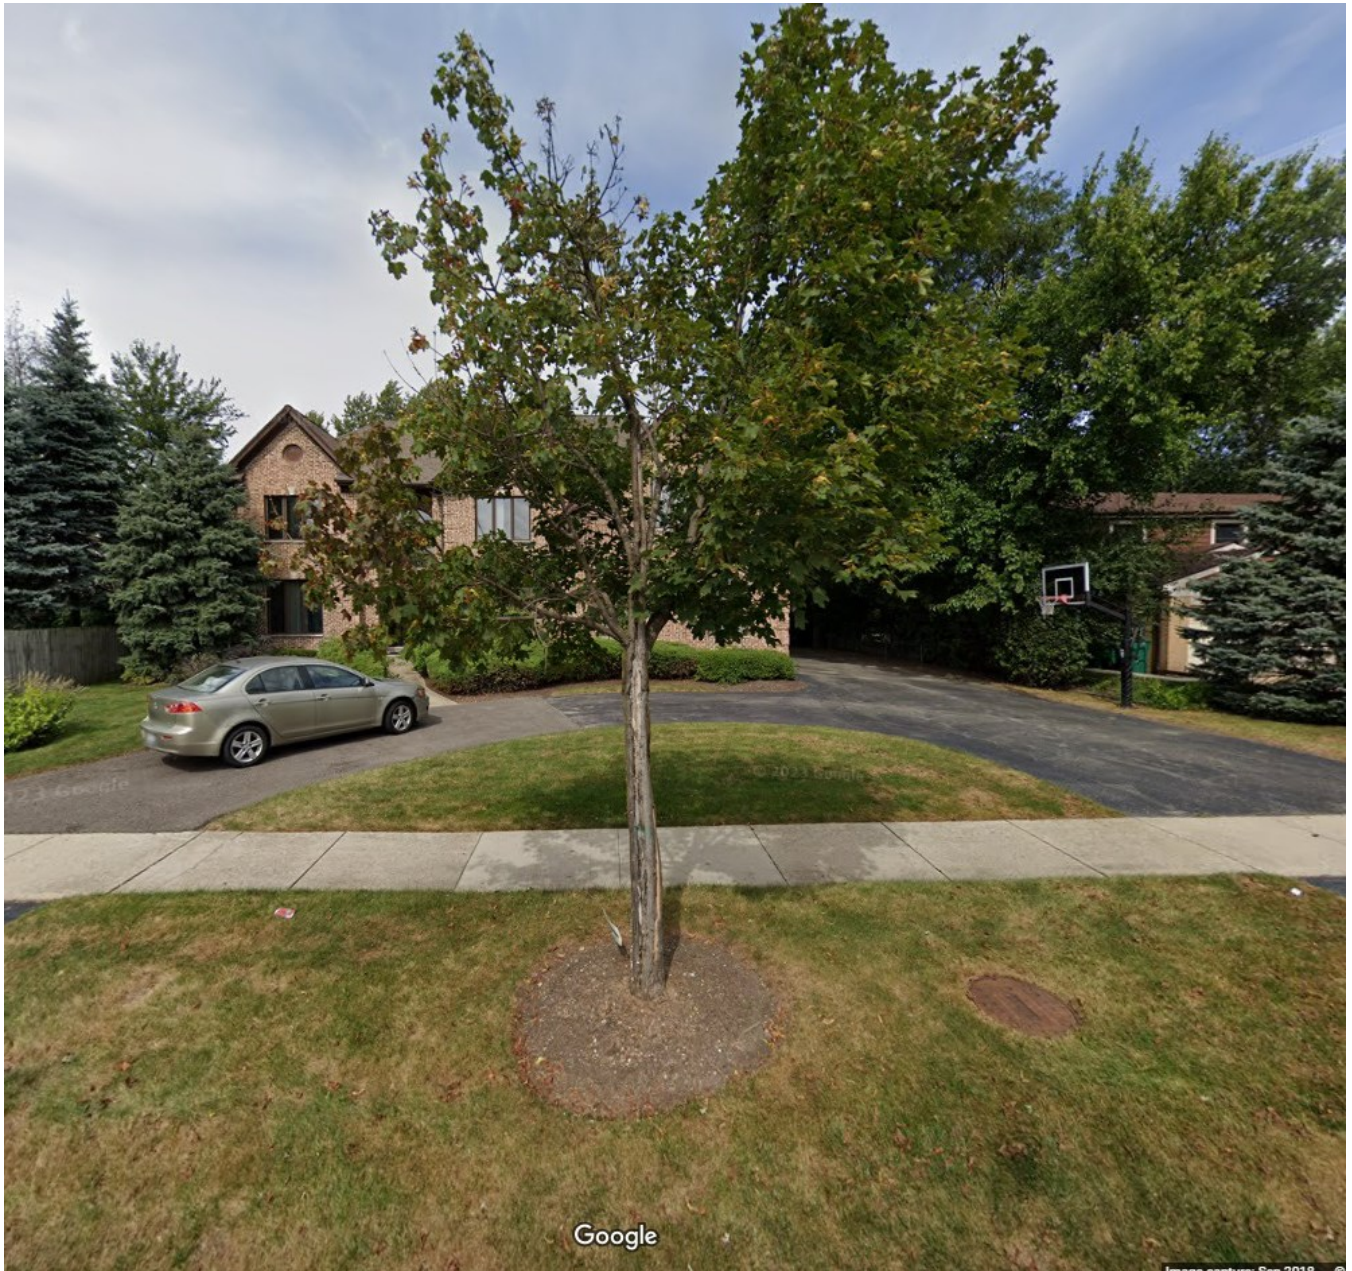
Tree	Address	Size	Species	Condition	Notes
1	1540 Hazel				Previously removed

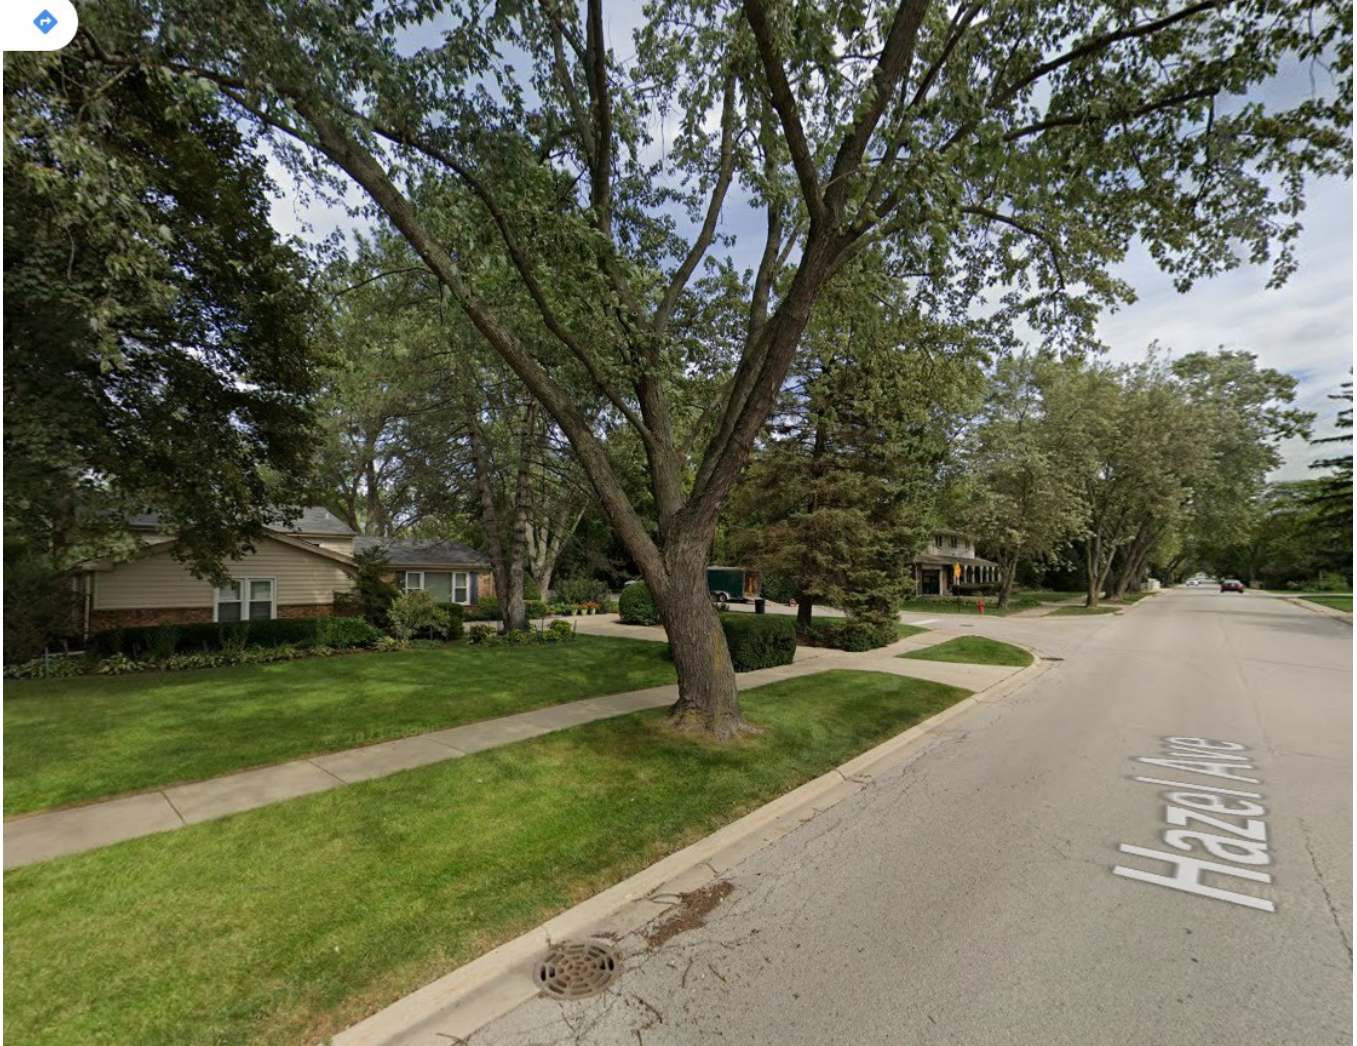
Tree	Address	Size	Species	Condition	Notes
2	1502 Hazel	35	Silver Maple	3	Storm sewer work in conflict. Multiple leaders, suckering, minor deadwood, weak crotches

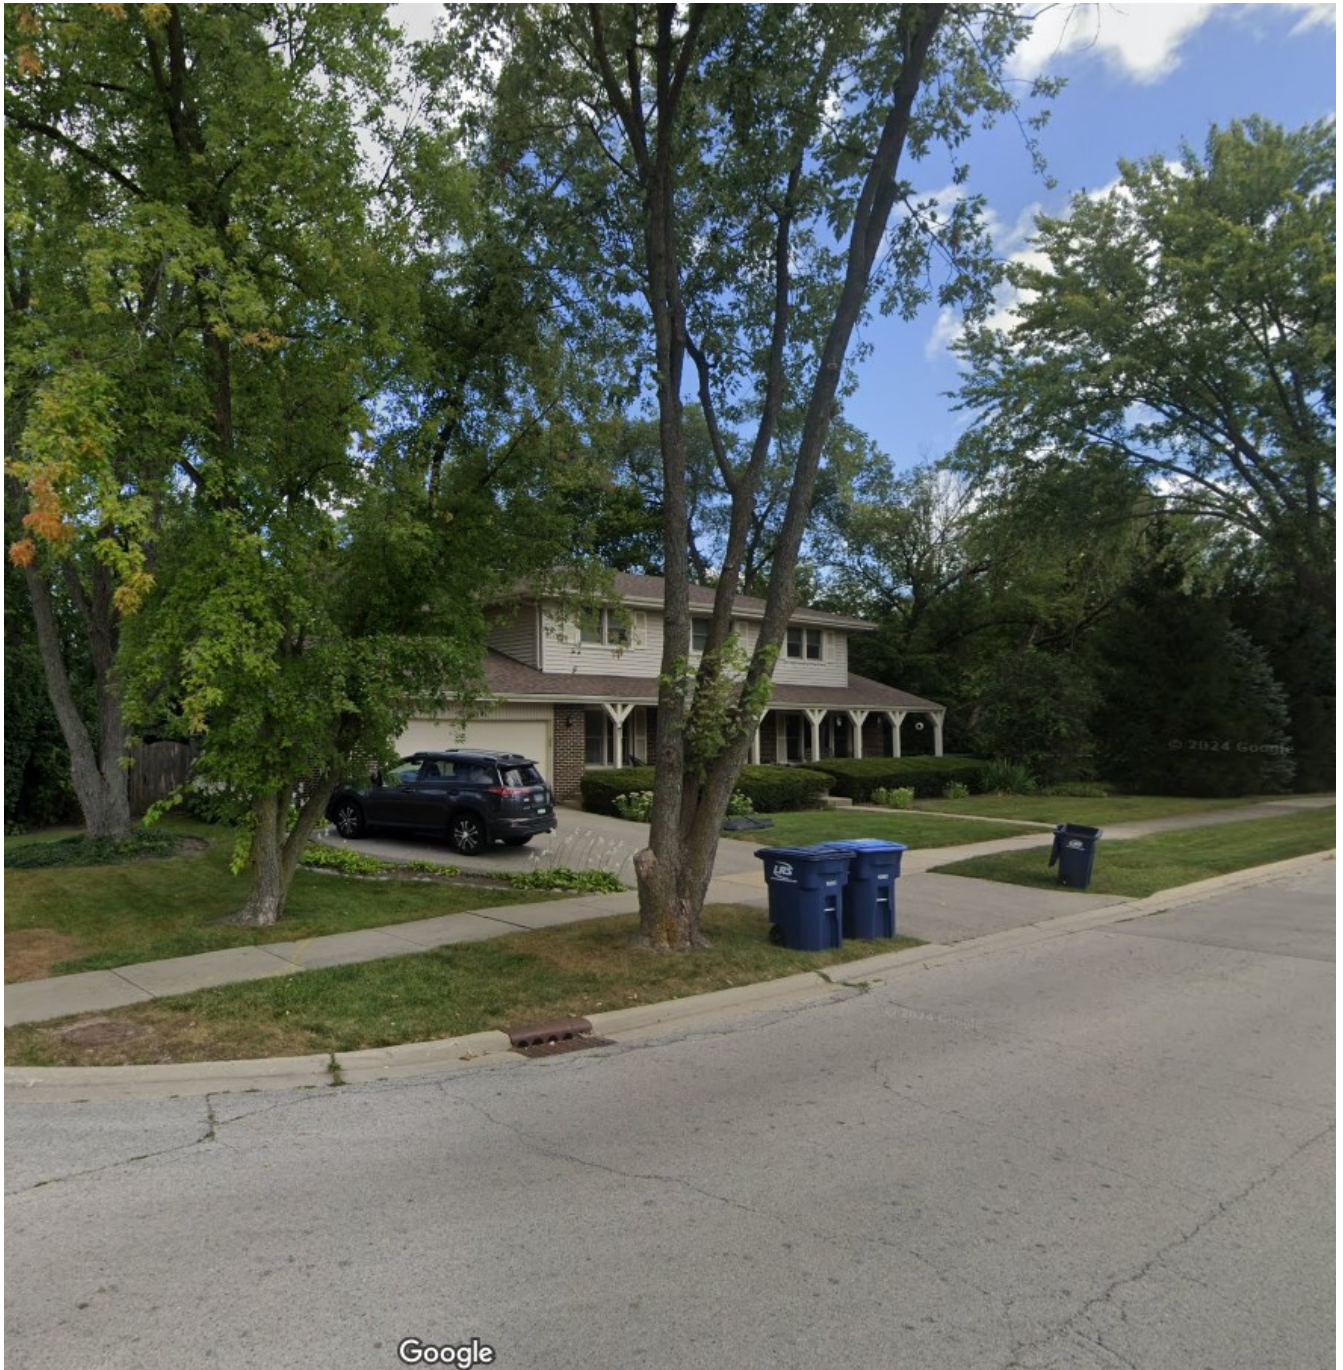
Tree	Address	Size	Species	Condition	Notes
3	1450 Hazel	12	Silver Maple	3/4	Storm sewer work and condition Trunk scar, weak crotch, decay multiple leaders, minor deadwood, fork at 3'

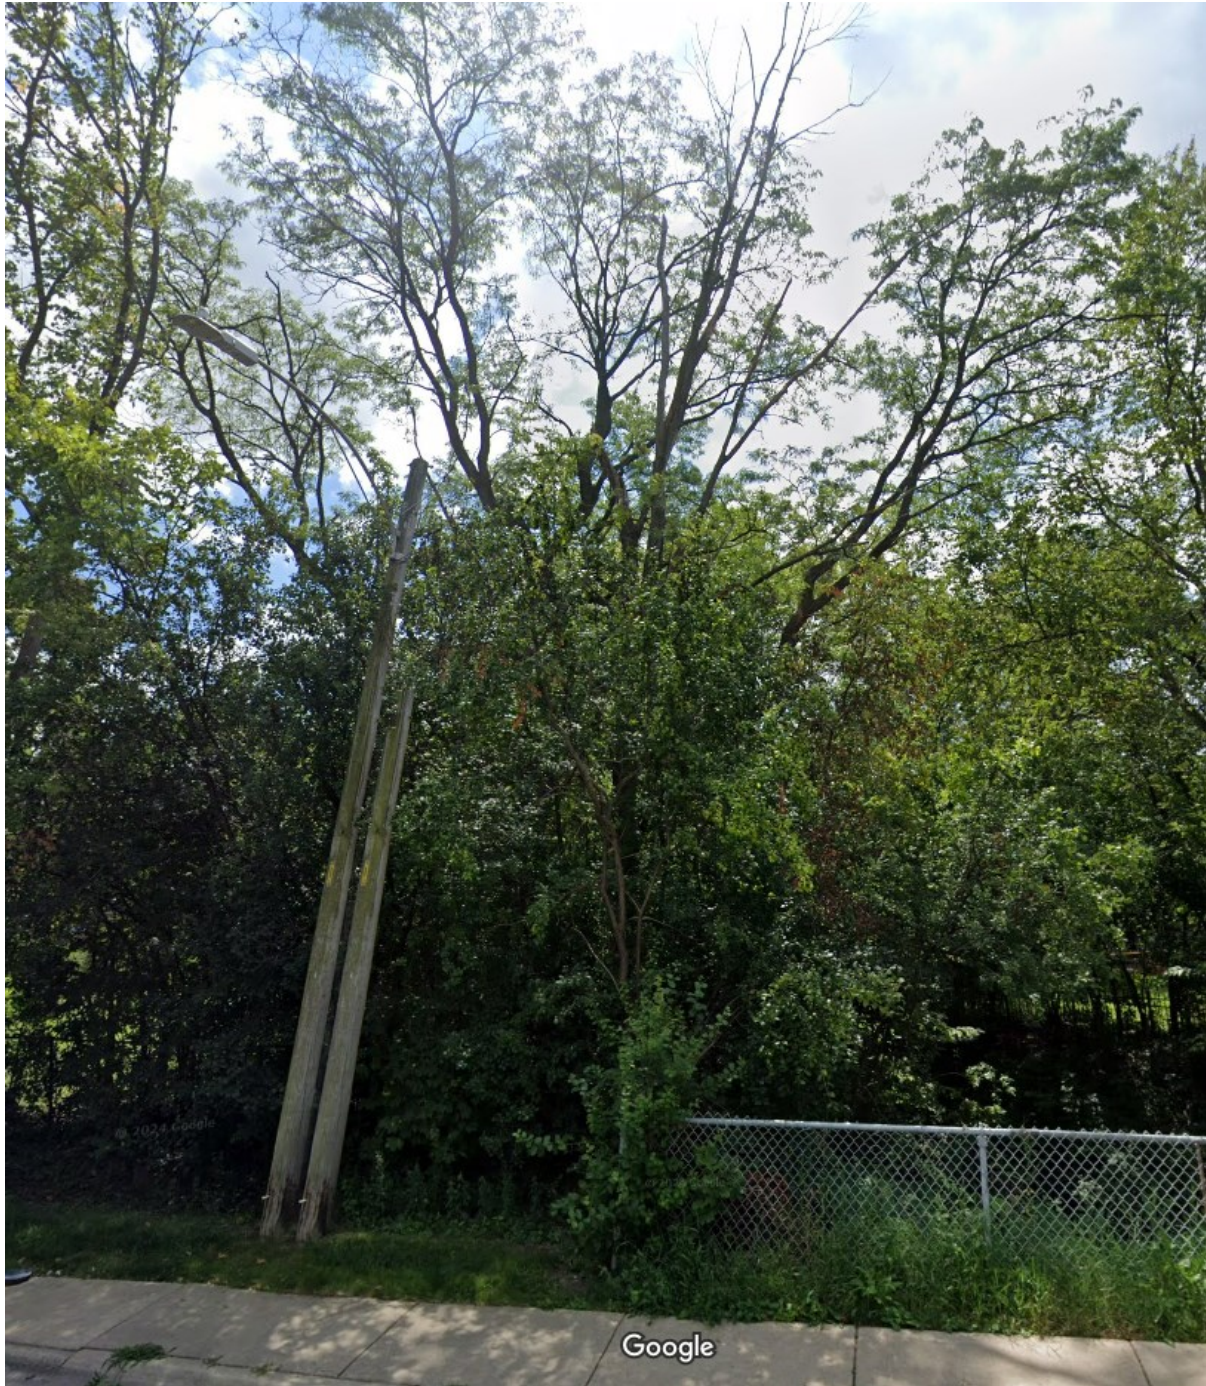
Tree	Address	Size	Species	Condition	Notes
4	978 Maple Ct	26	Siberian Elm	3	Storm sewer work weak crotch, one-sided, multiple leaders, slight sweep, minor deadwood

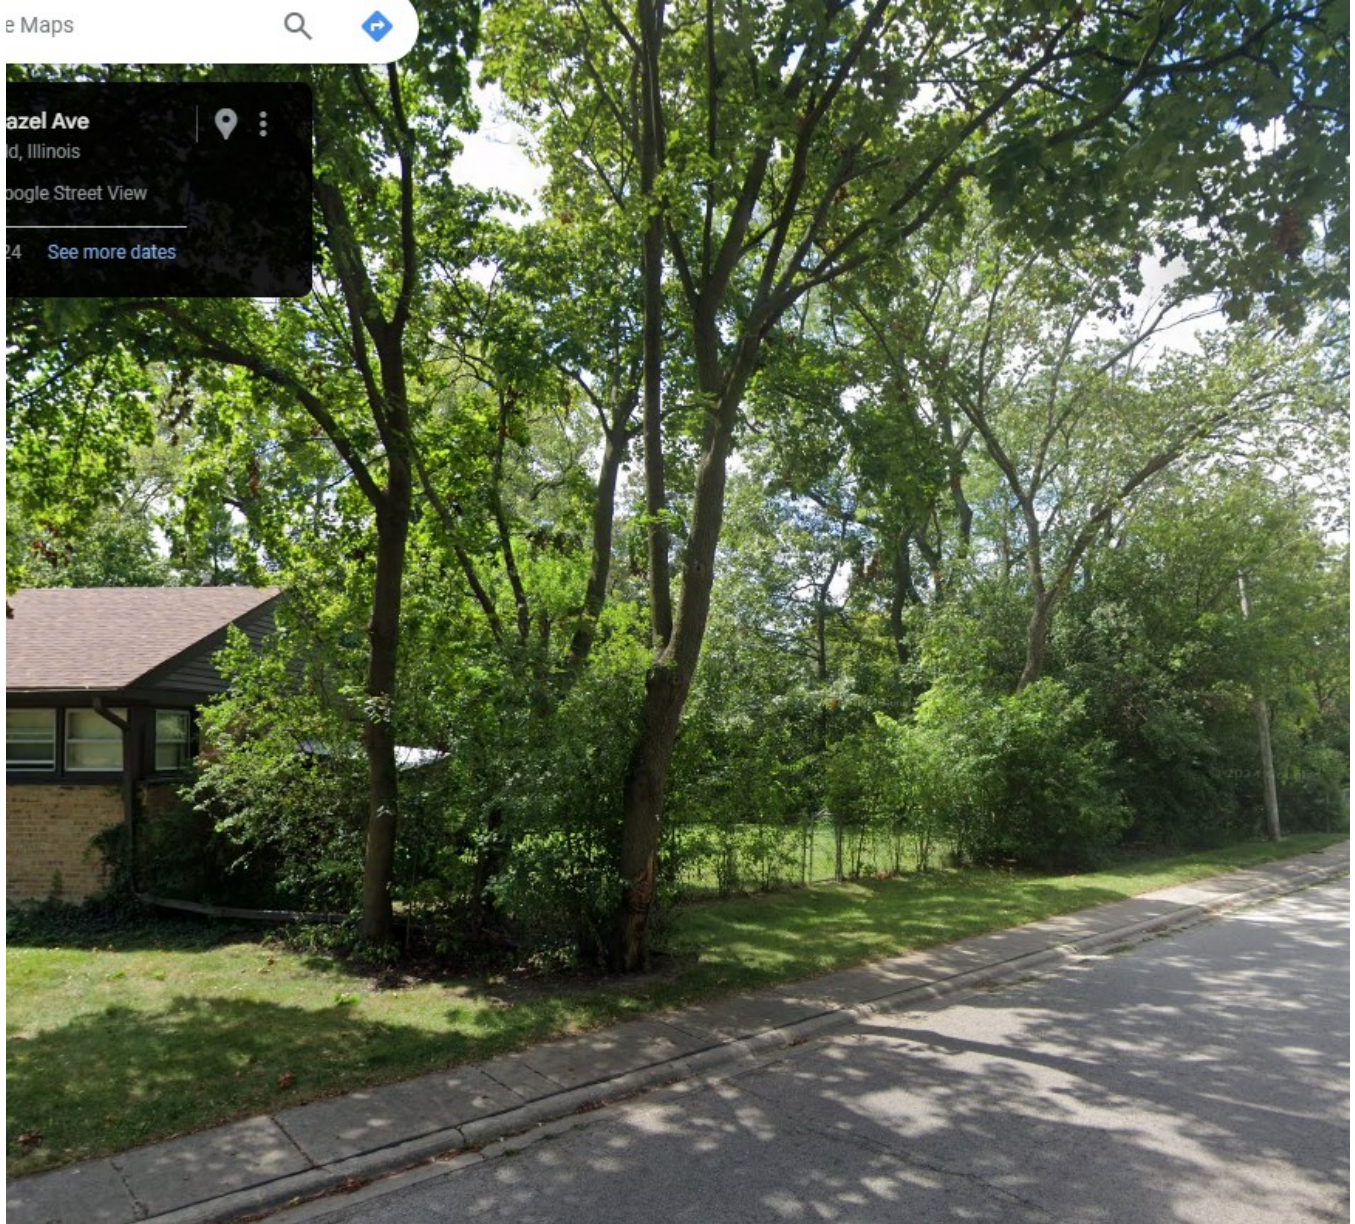
Tree	Address	Size	Species	Condition	Notes
5	978 Maple Ct	15	Norway Maple	3	Sidewalk work slight lean, weak crotch, multiple leaders, broken branches

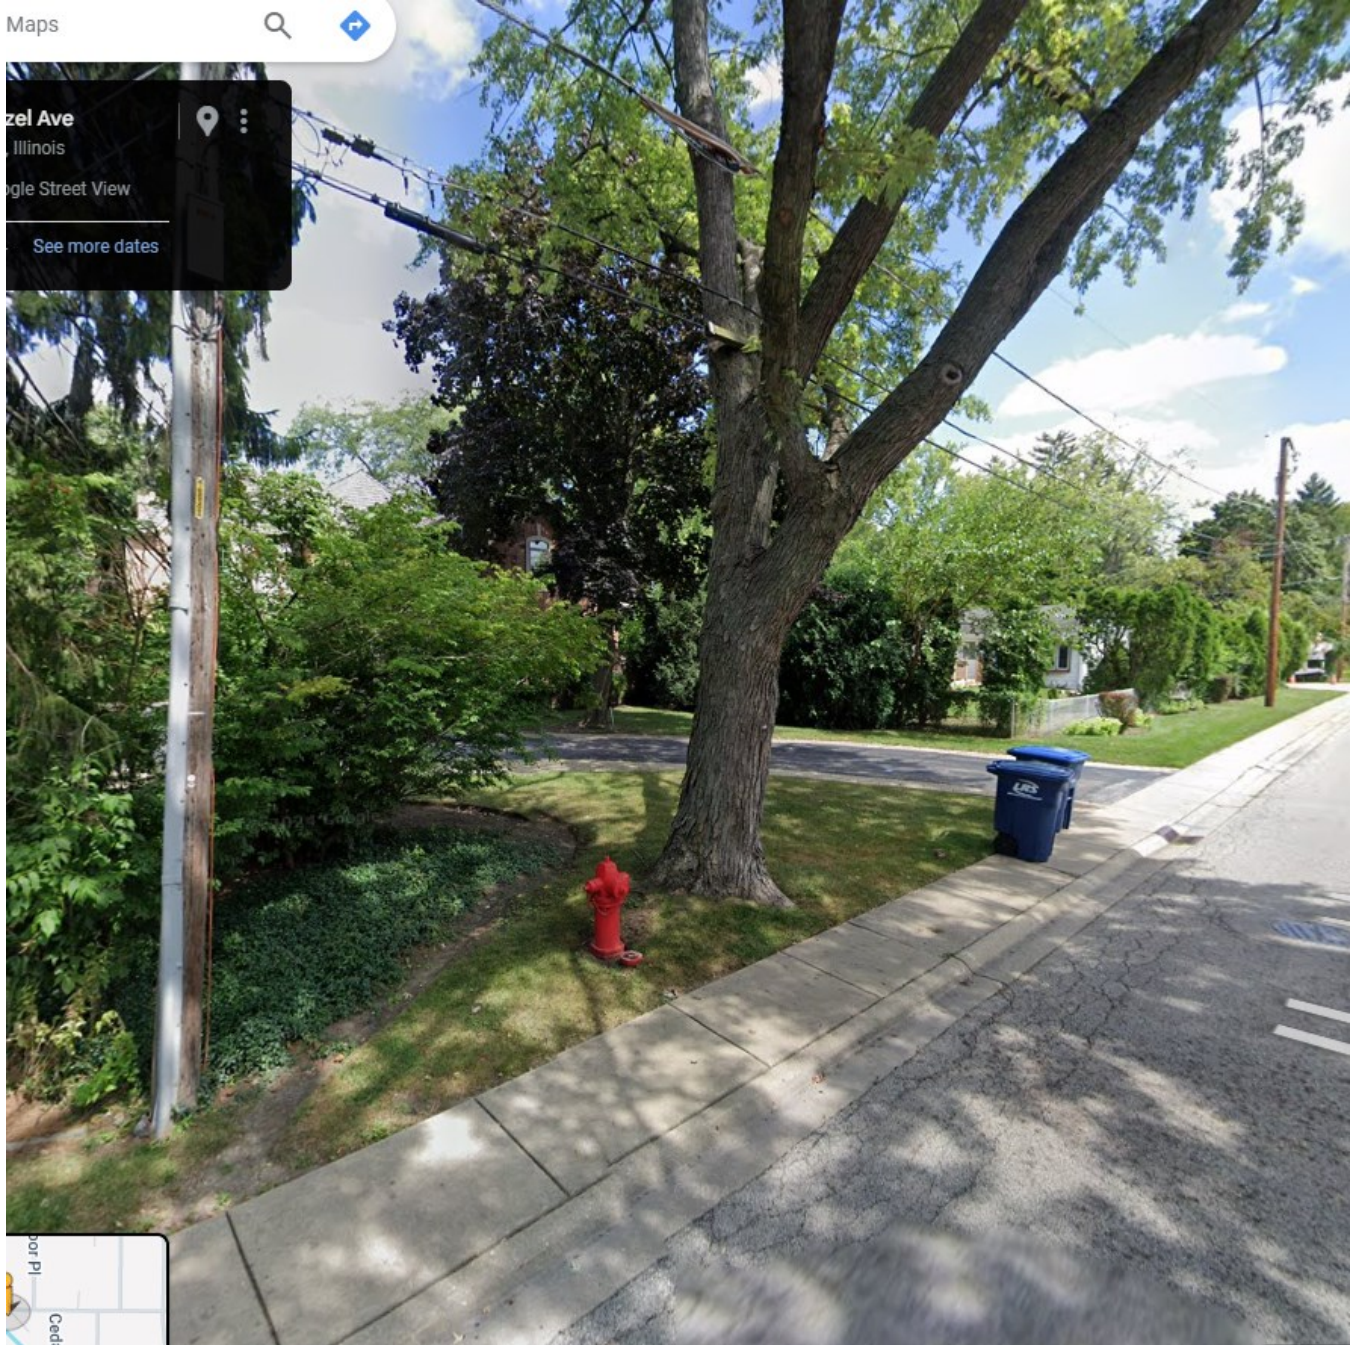
Tree	Address	Size	Species	Condition	Notes
6	1414 Hazel	32	Silver Maple	3	Sidewalk and power lines work Multiple leaders, suckering, minor deadwood, overhead wires

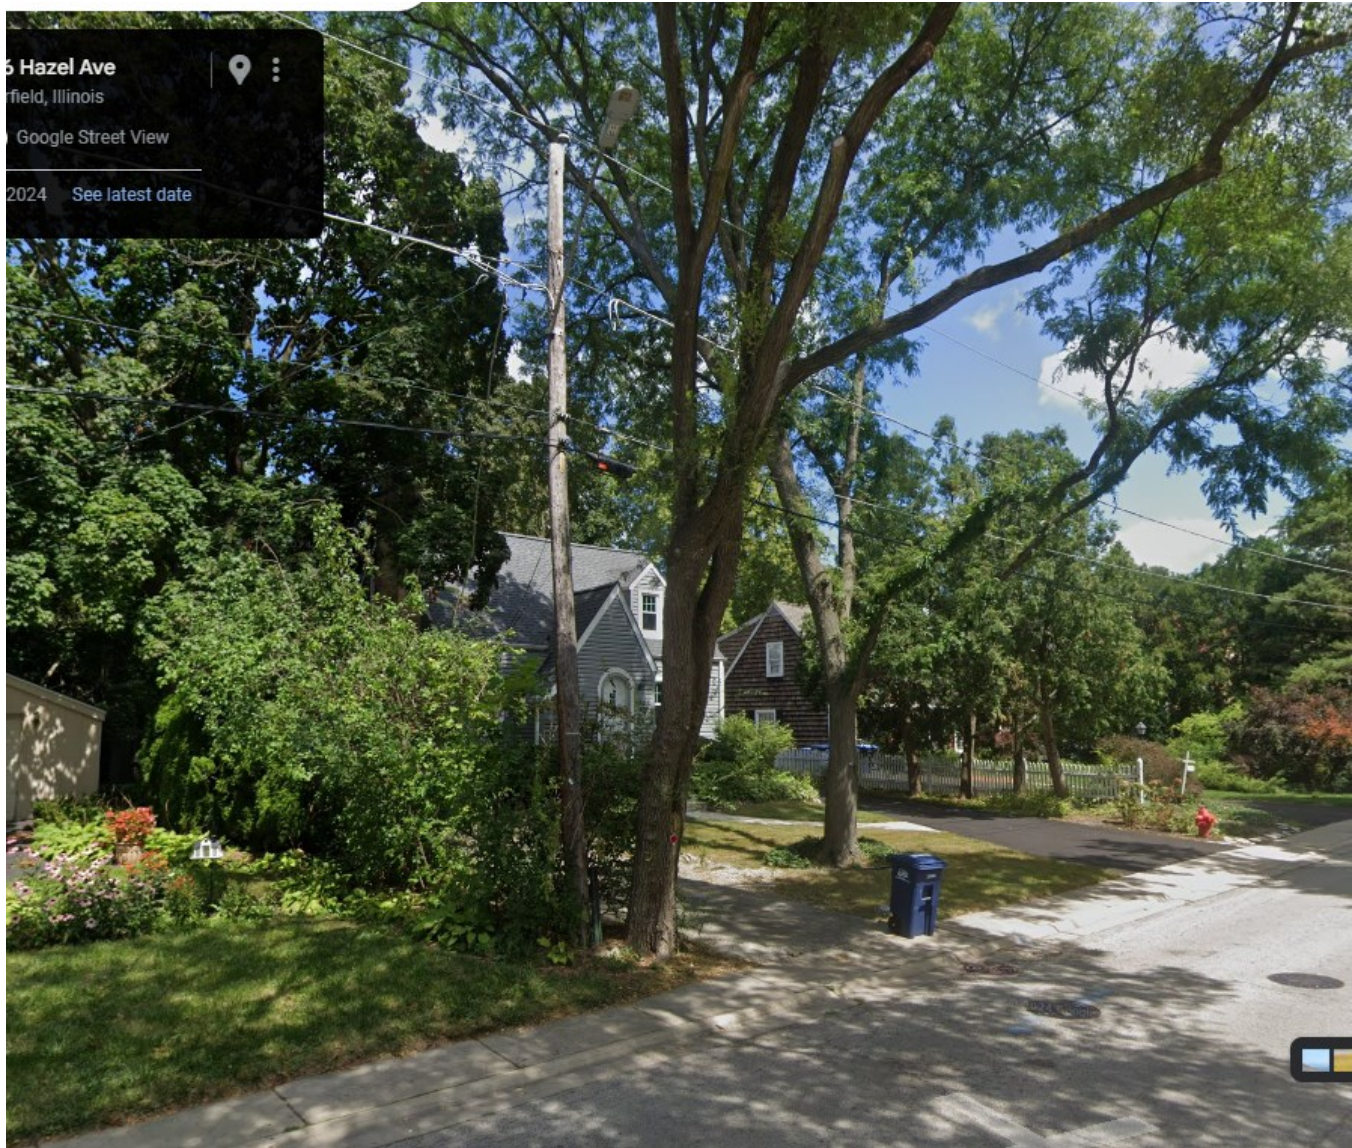
Tree	Address	Size	Species	Condition	Notes
9	1344 Hazel	19	Siberian Elm	3	Sidewalk and power lines work Multiple leaders, suckering, minor deadwood, overhead wires
8		12	Mulberry		Previously removed
7		20	Mulberry		Previously removed

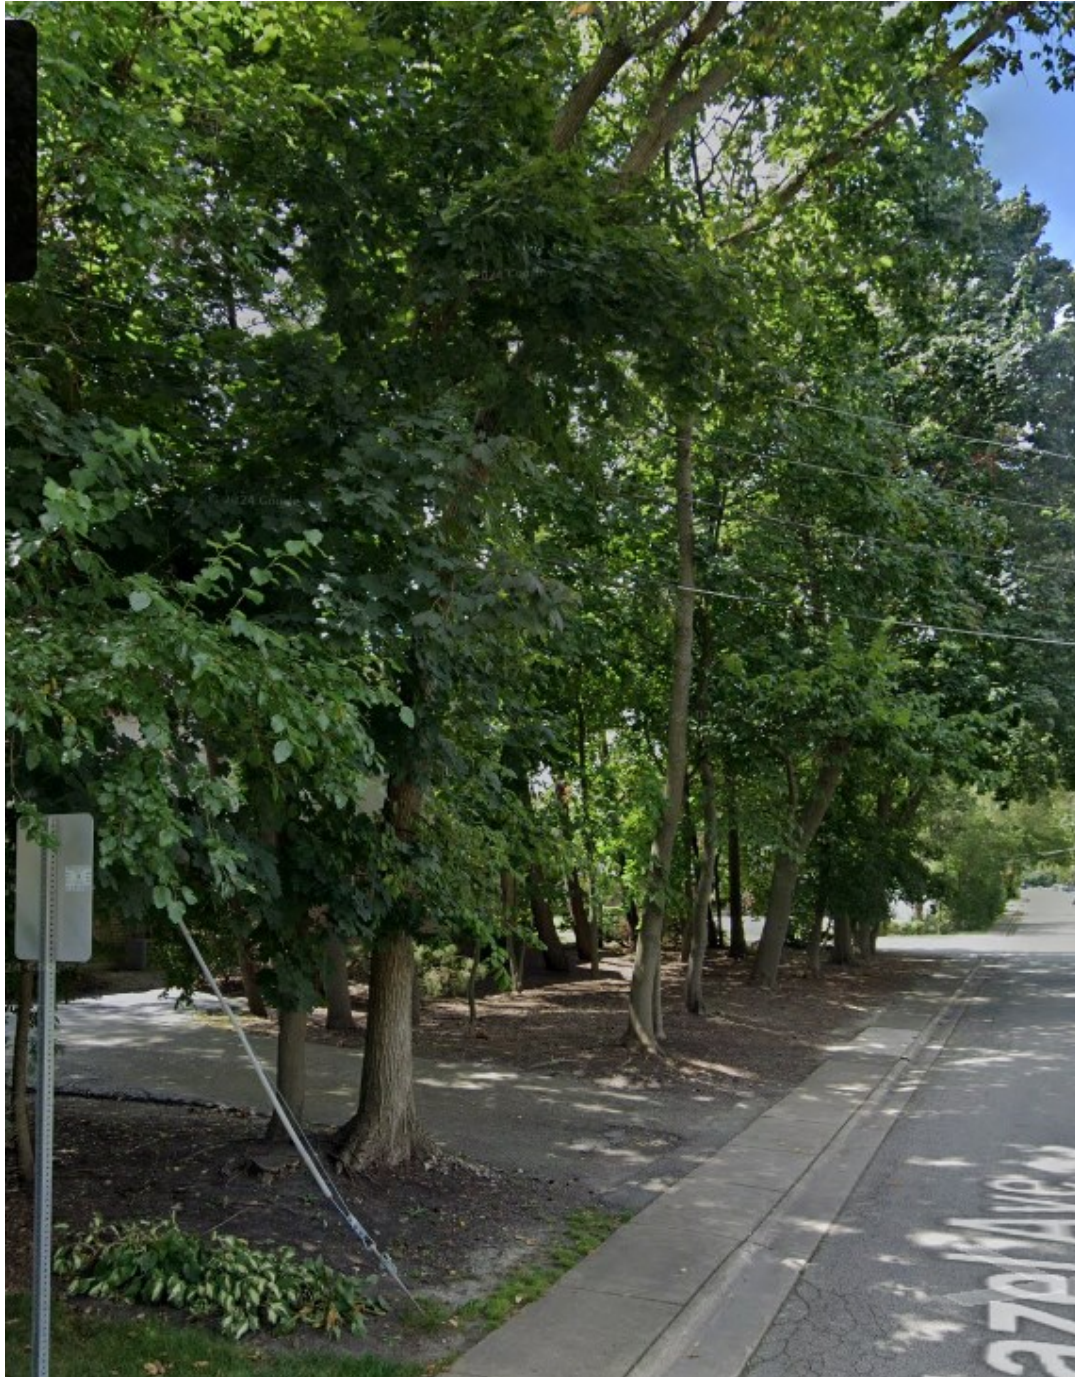
Tree	Address	Size	Species	Condition	Notes
10	963 Cedar St	11	Norway Maple	3	Sidewalk work? twist in trunk, pruned for side wires, one sided
11A	963 Cedar St	14	American Elm	3	Sidewalk work? Sweep, multiple leaders, pruned for side wires, minor deadwood, suckering
11B	963 Cedar St	8	Norway Maple	4	Sidewalk work? damaged leader, pruned for overhead wires, one sided, suckering

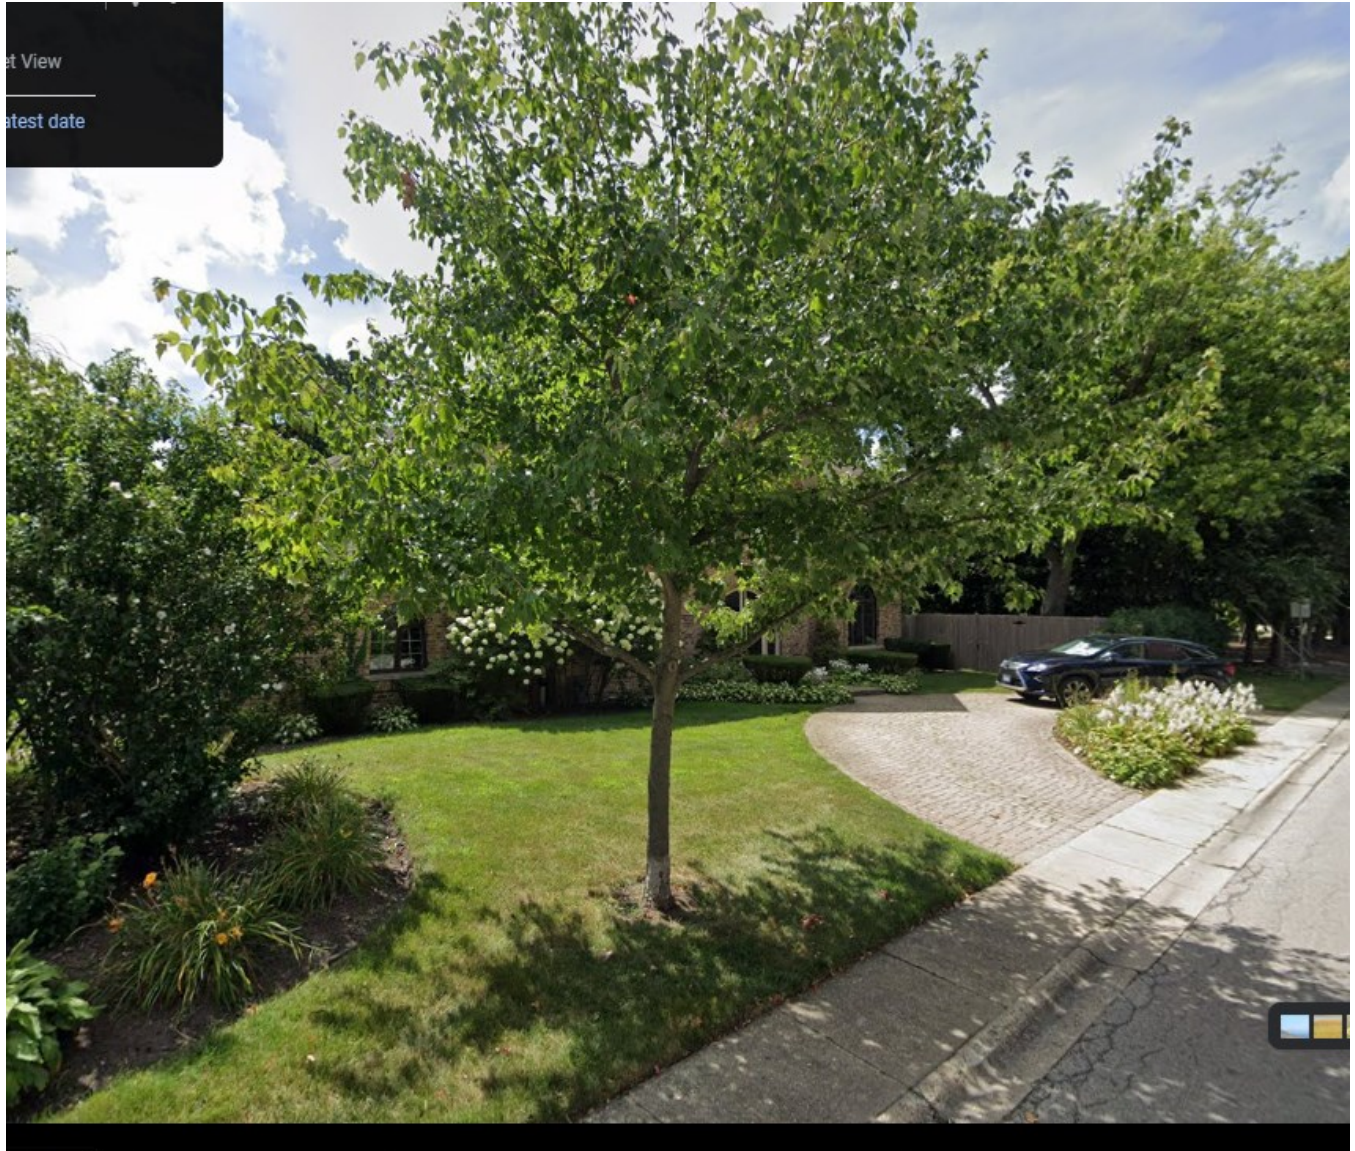
Tree	Address	Size	Species	Condition	Notes
12	1315 Hazel	5	Red Maple	3	Sidewalk work Basal scar

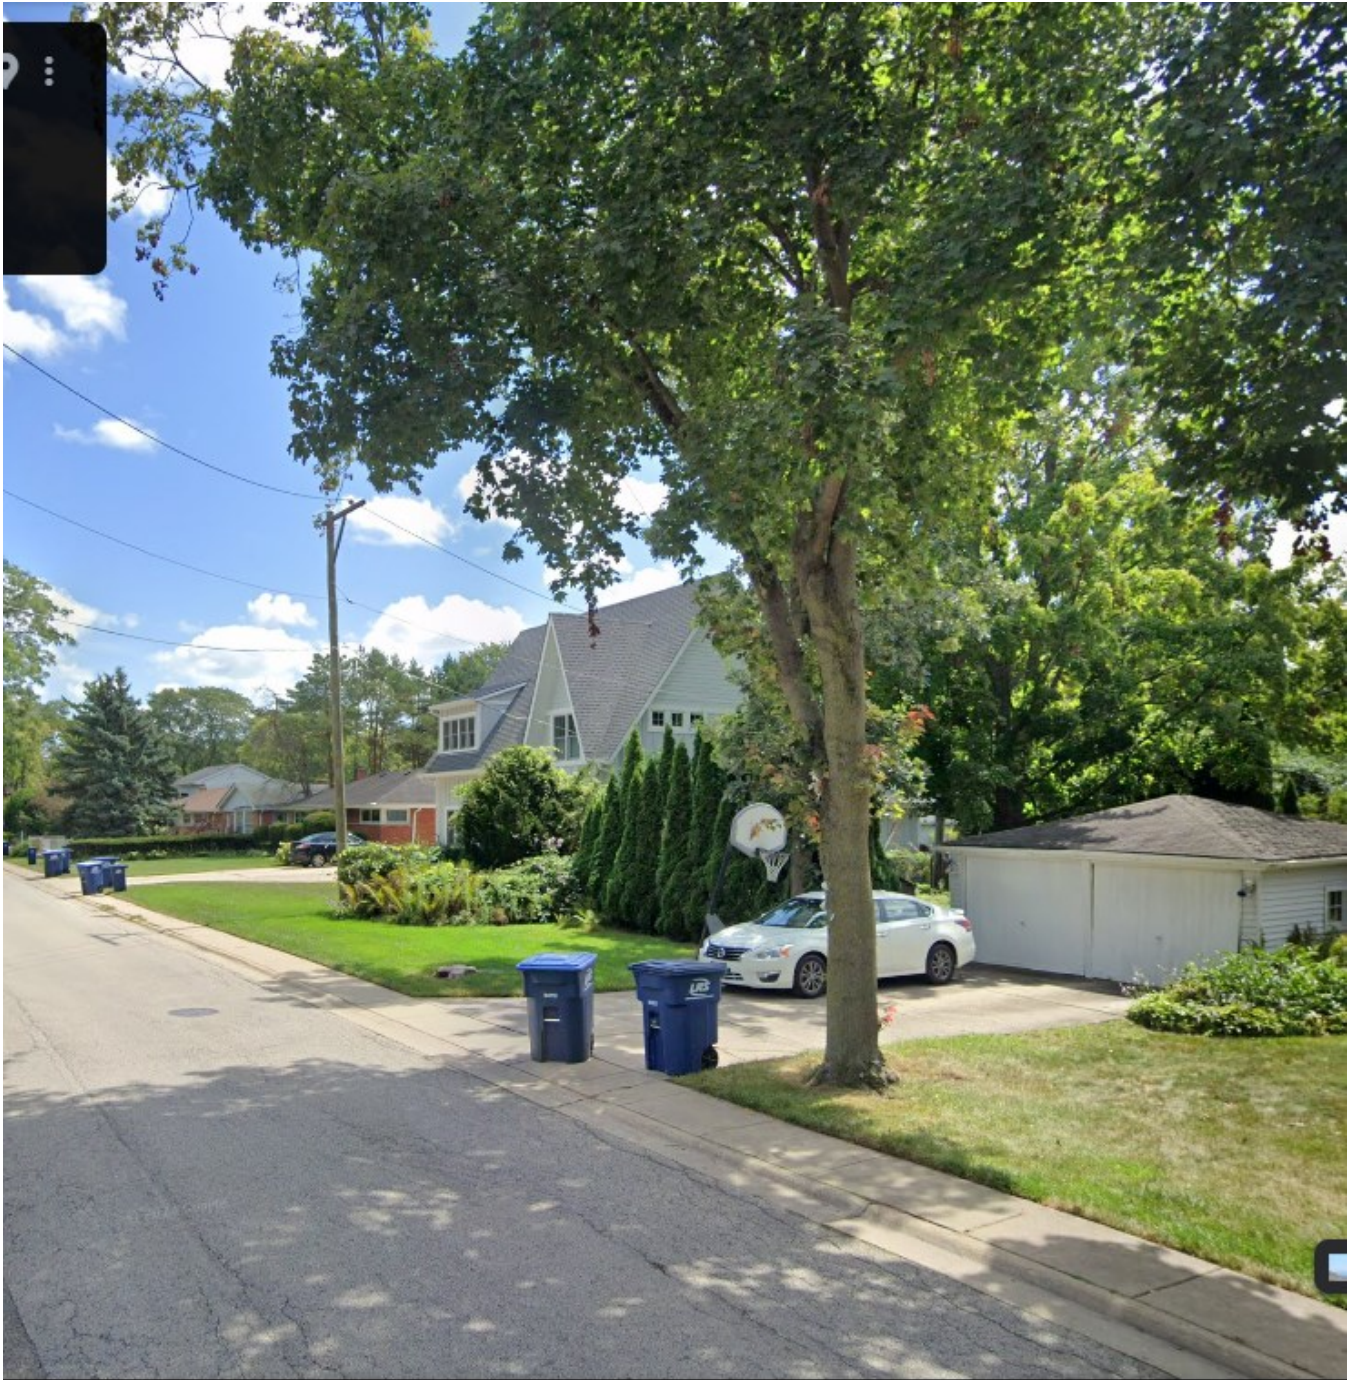
Tree	Address	Size	Species	Condition	Notes
13	951 Hemlock	17	Norway Maple	3	Sidewalk work weak crotch, multiple leaders, sucker growth, broken branches
14		18	Norway Maple		Previously removed

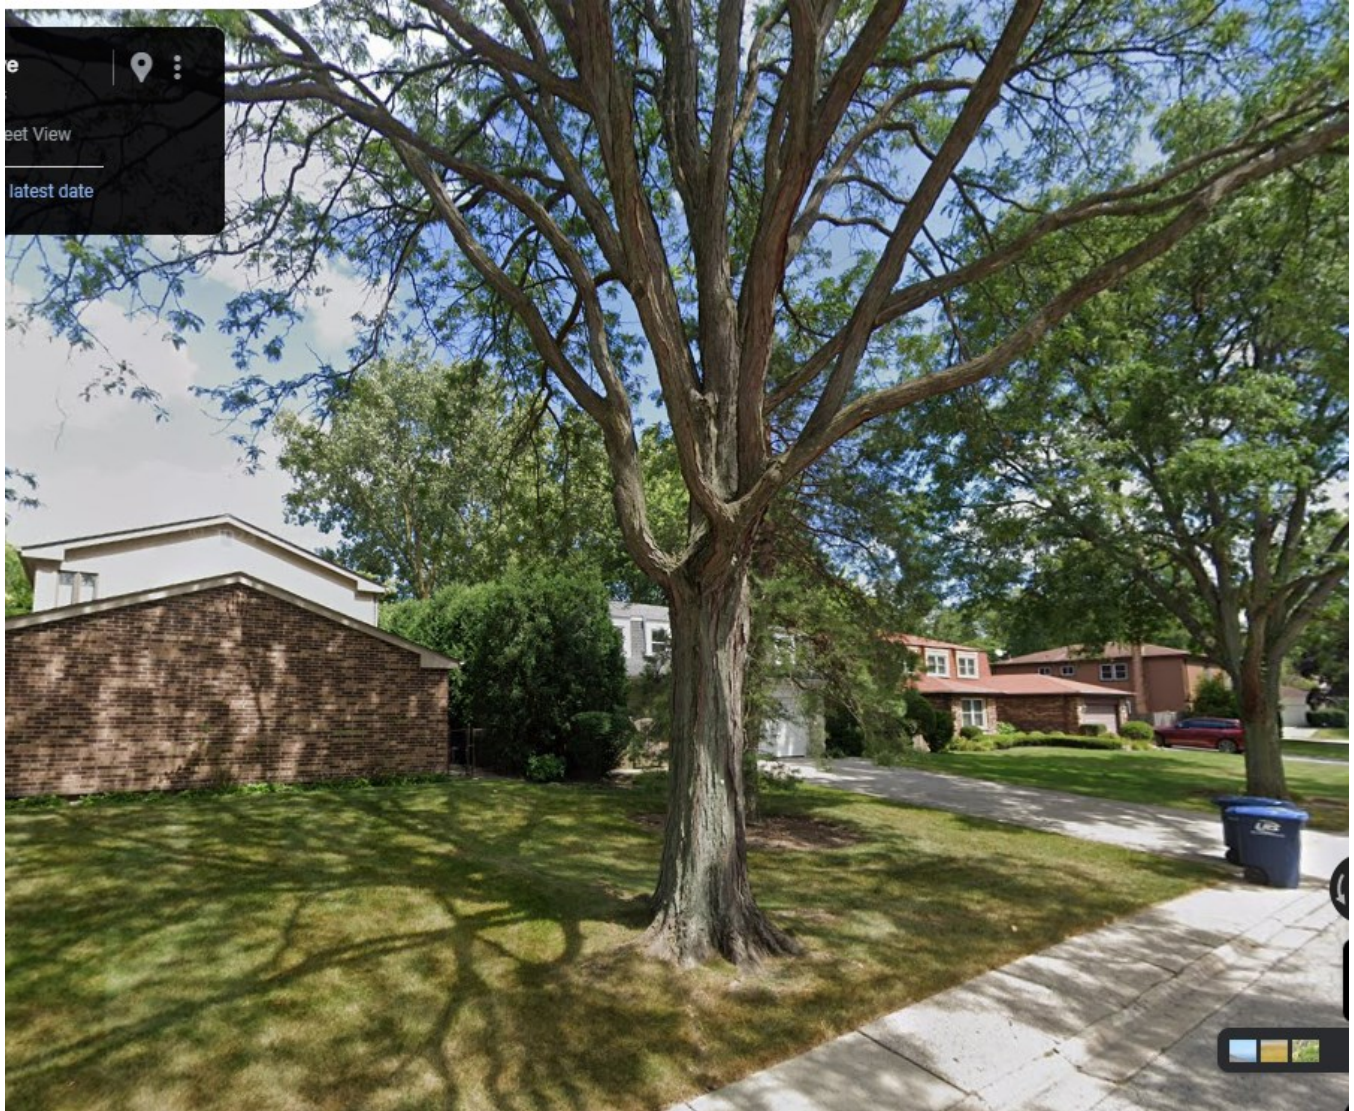
Tree	Address	Size	Species	Condition	Notes
15	1007 Prairie	31	Honey locust	2	Sidewalk work weak crotch, multiple leaders, sucker growth

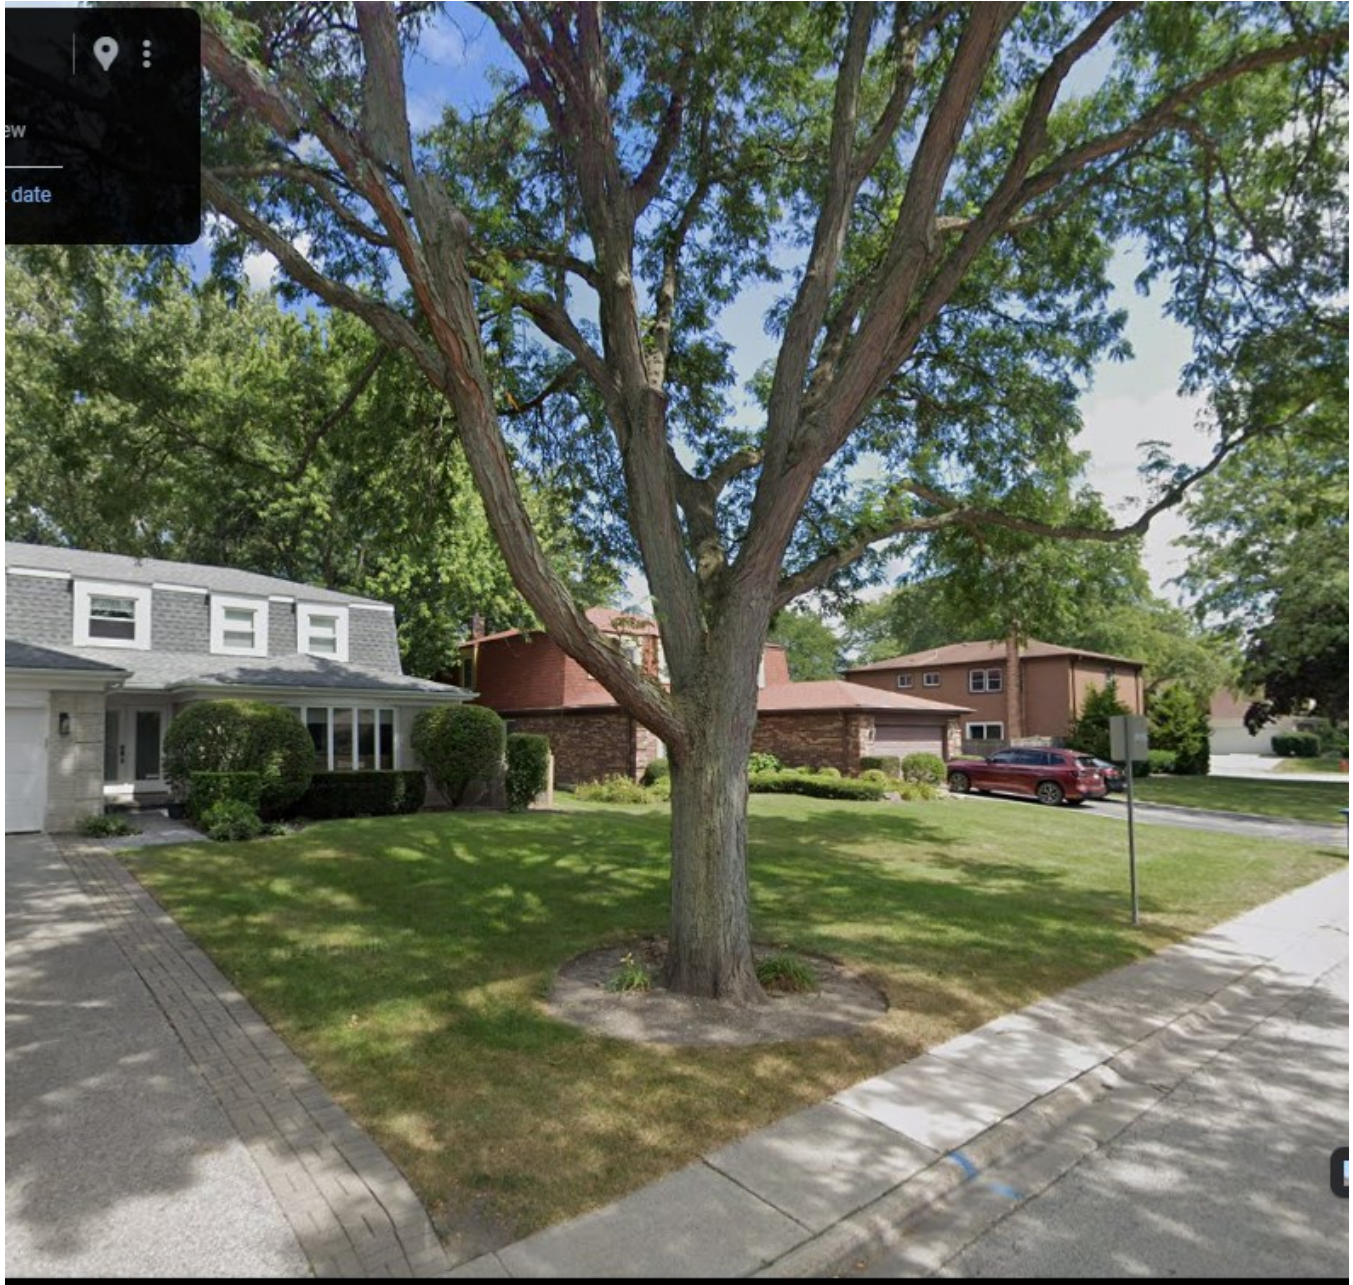
Tree	Address	Size	Species	Condition	Notes
16	1250 Hazel	24	Honey locust	3	Sidewalk work multiple leaders, broken branches, minor deadwood, sucker growth

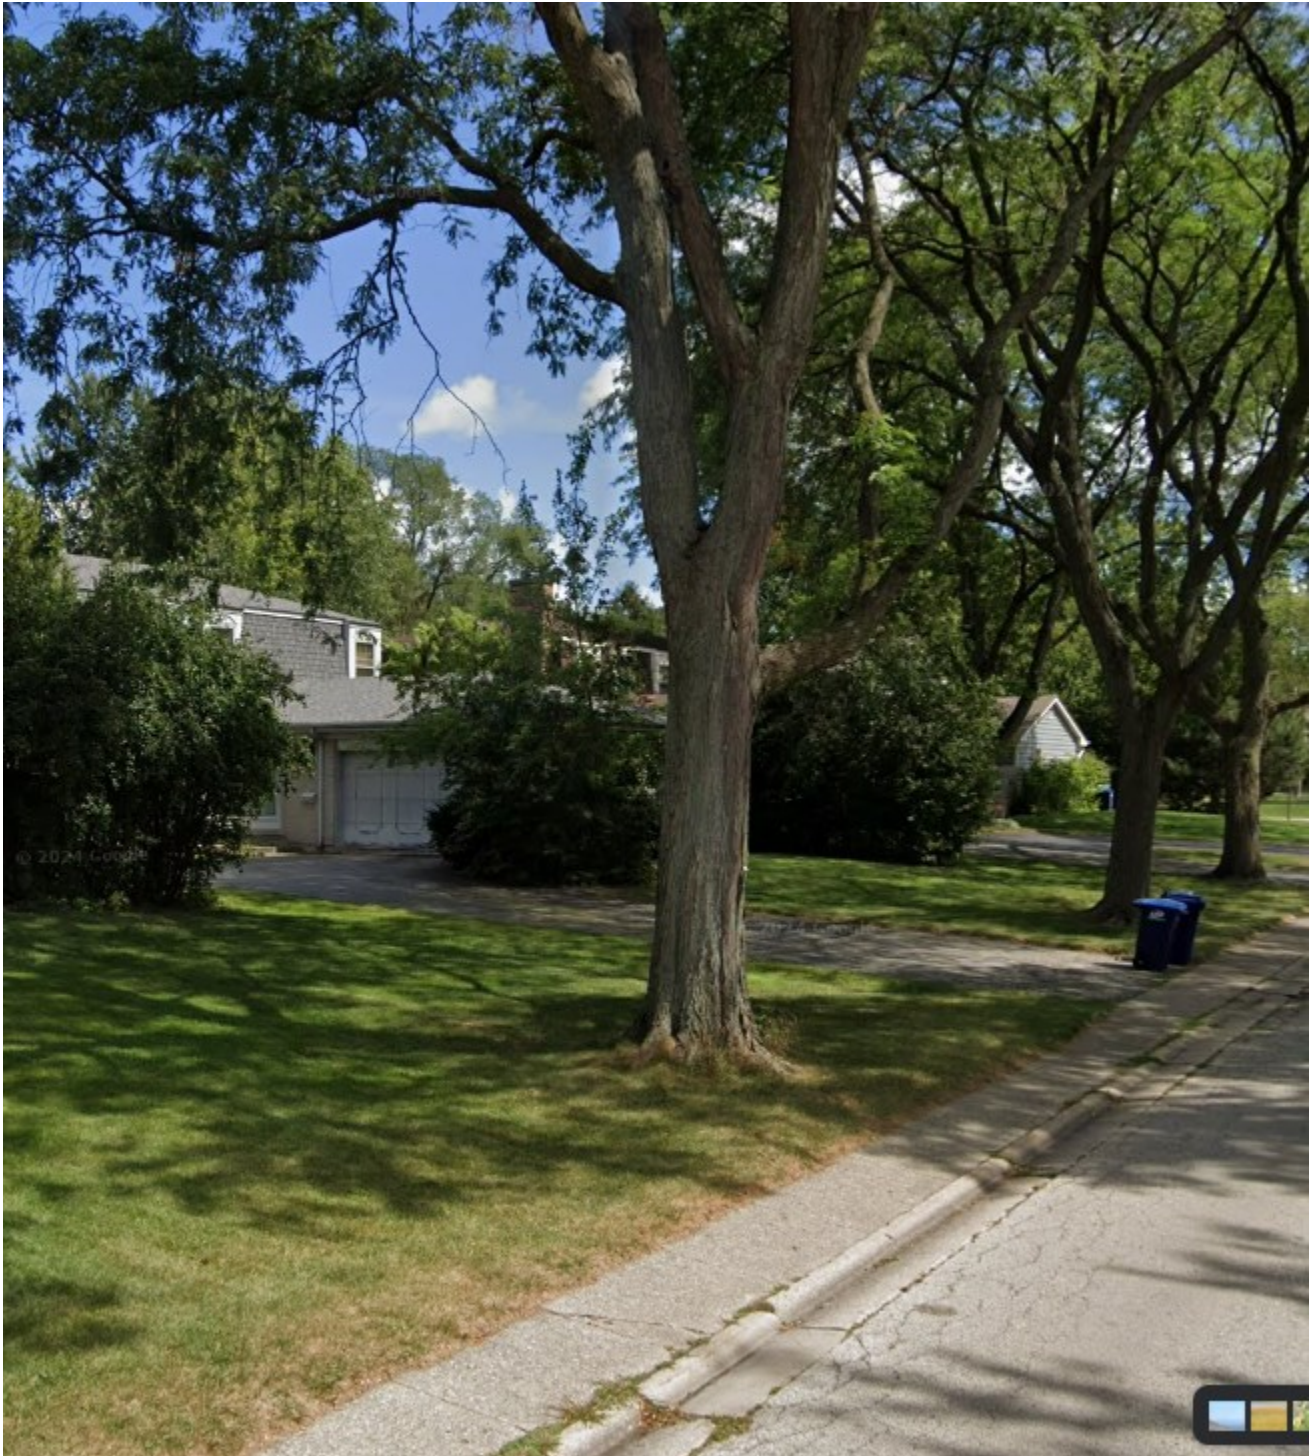
Tree	Address	Size	Species	Condition	Notes
17A	1005 Stratford	30	Honey locust	3	Sidewalk work weak crotch, multiple leaders, minor deadwood
