Hazel Avenue Infrastructure Project

Tree Impact Inventory

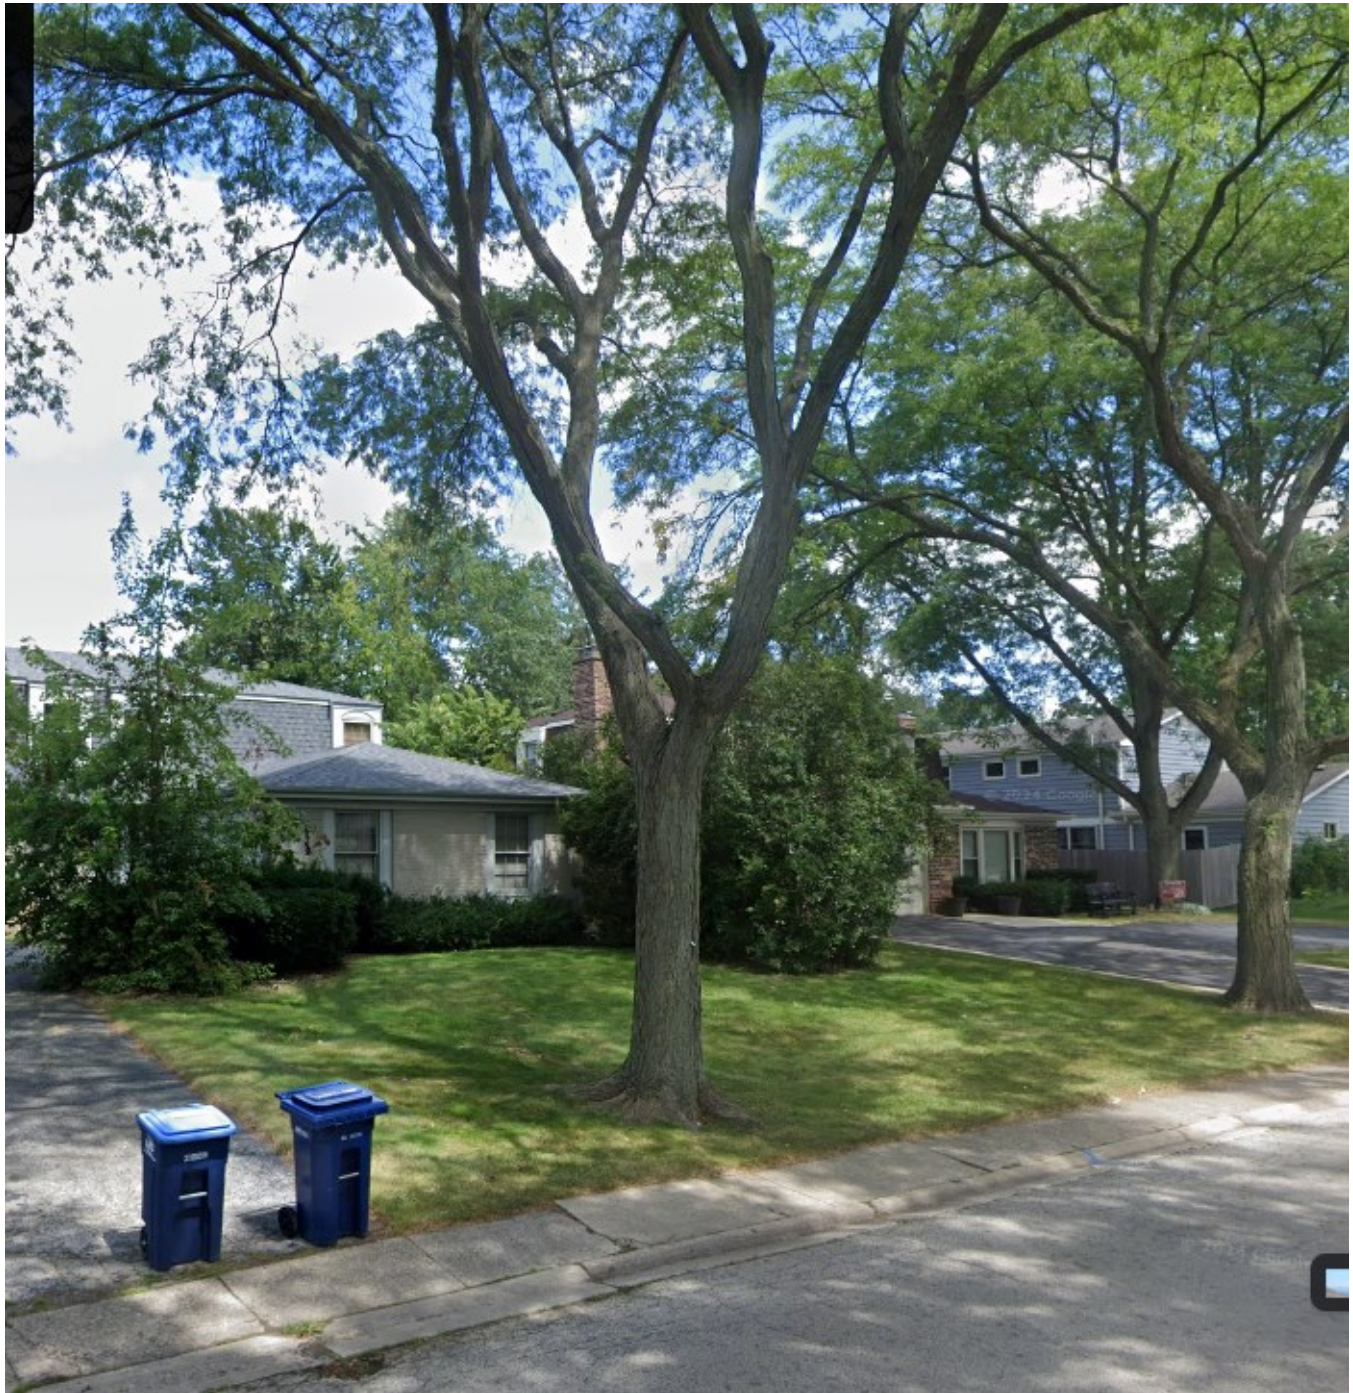
Tree	Address	Size	Species	Condition	Notes
17B	1216 Hazel	24	Honey locust	3	Sidewalk work weak crotch, multiple leaders, sucker growth, minor deadwood

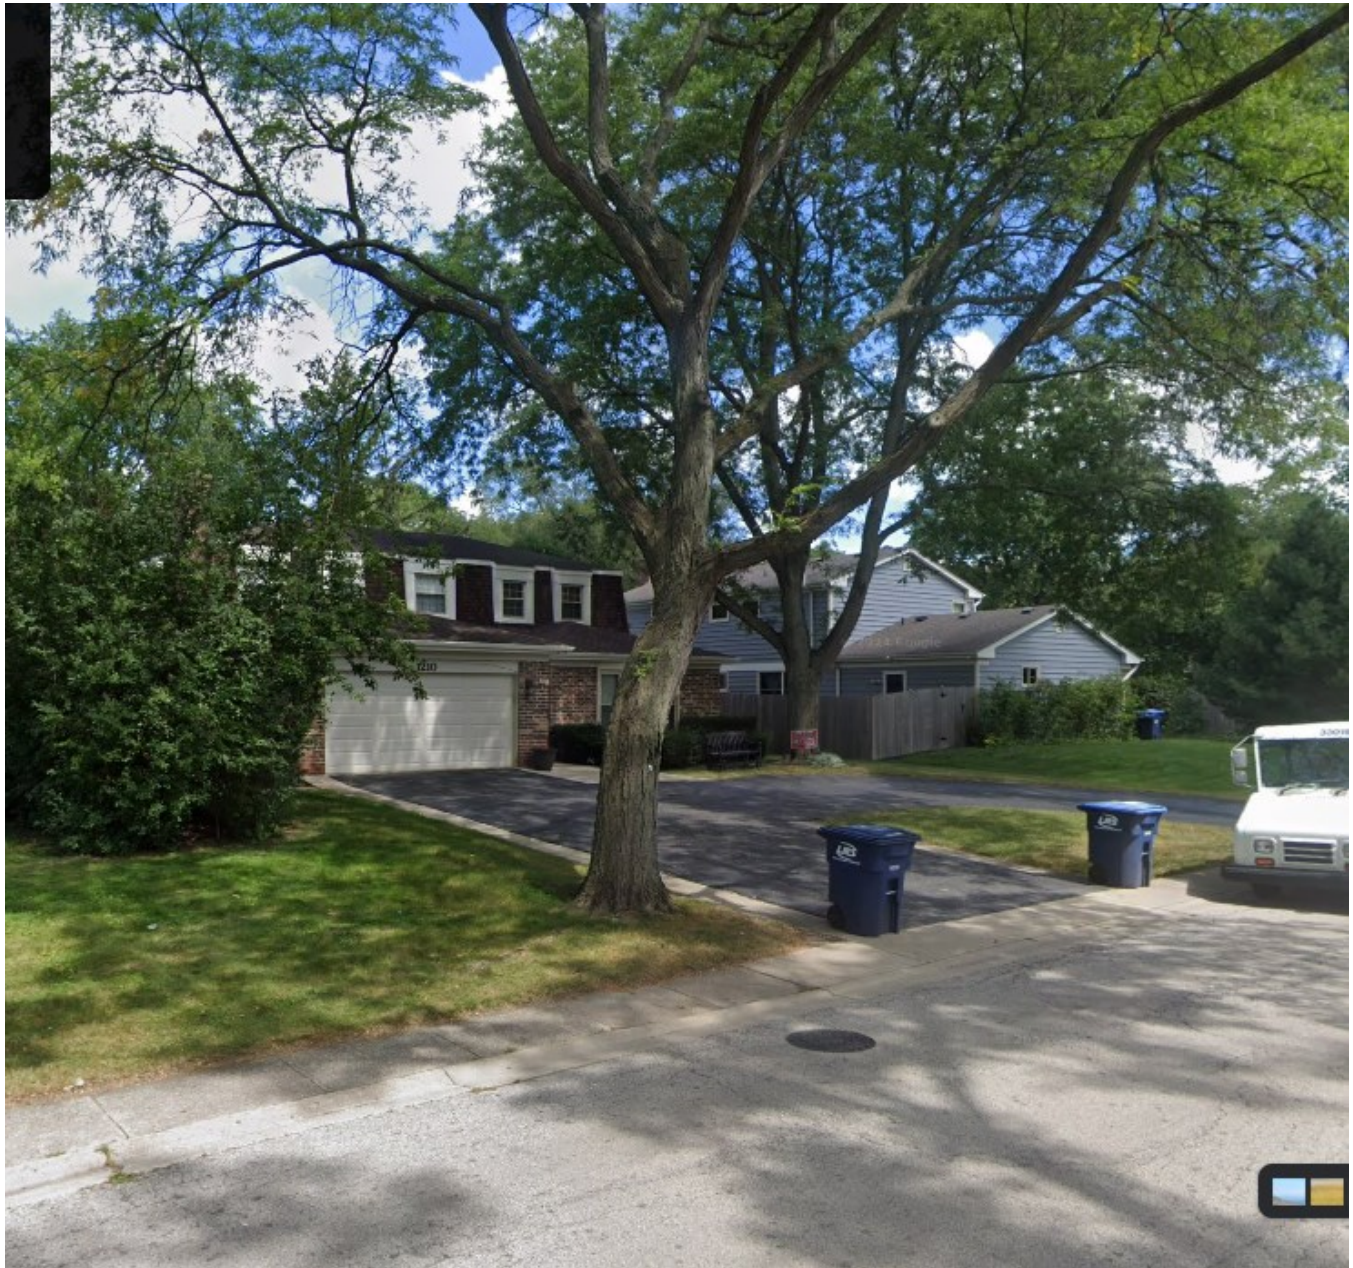
Tree	Address	Size	Species	Condition	Notes
18	1210 Hazel	25	Honey locust	3	Sidewalk work slight sweep, multiple leaders, sucker growth, minor deadwood

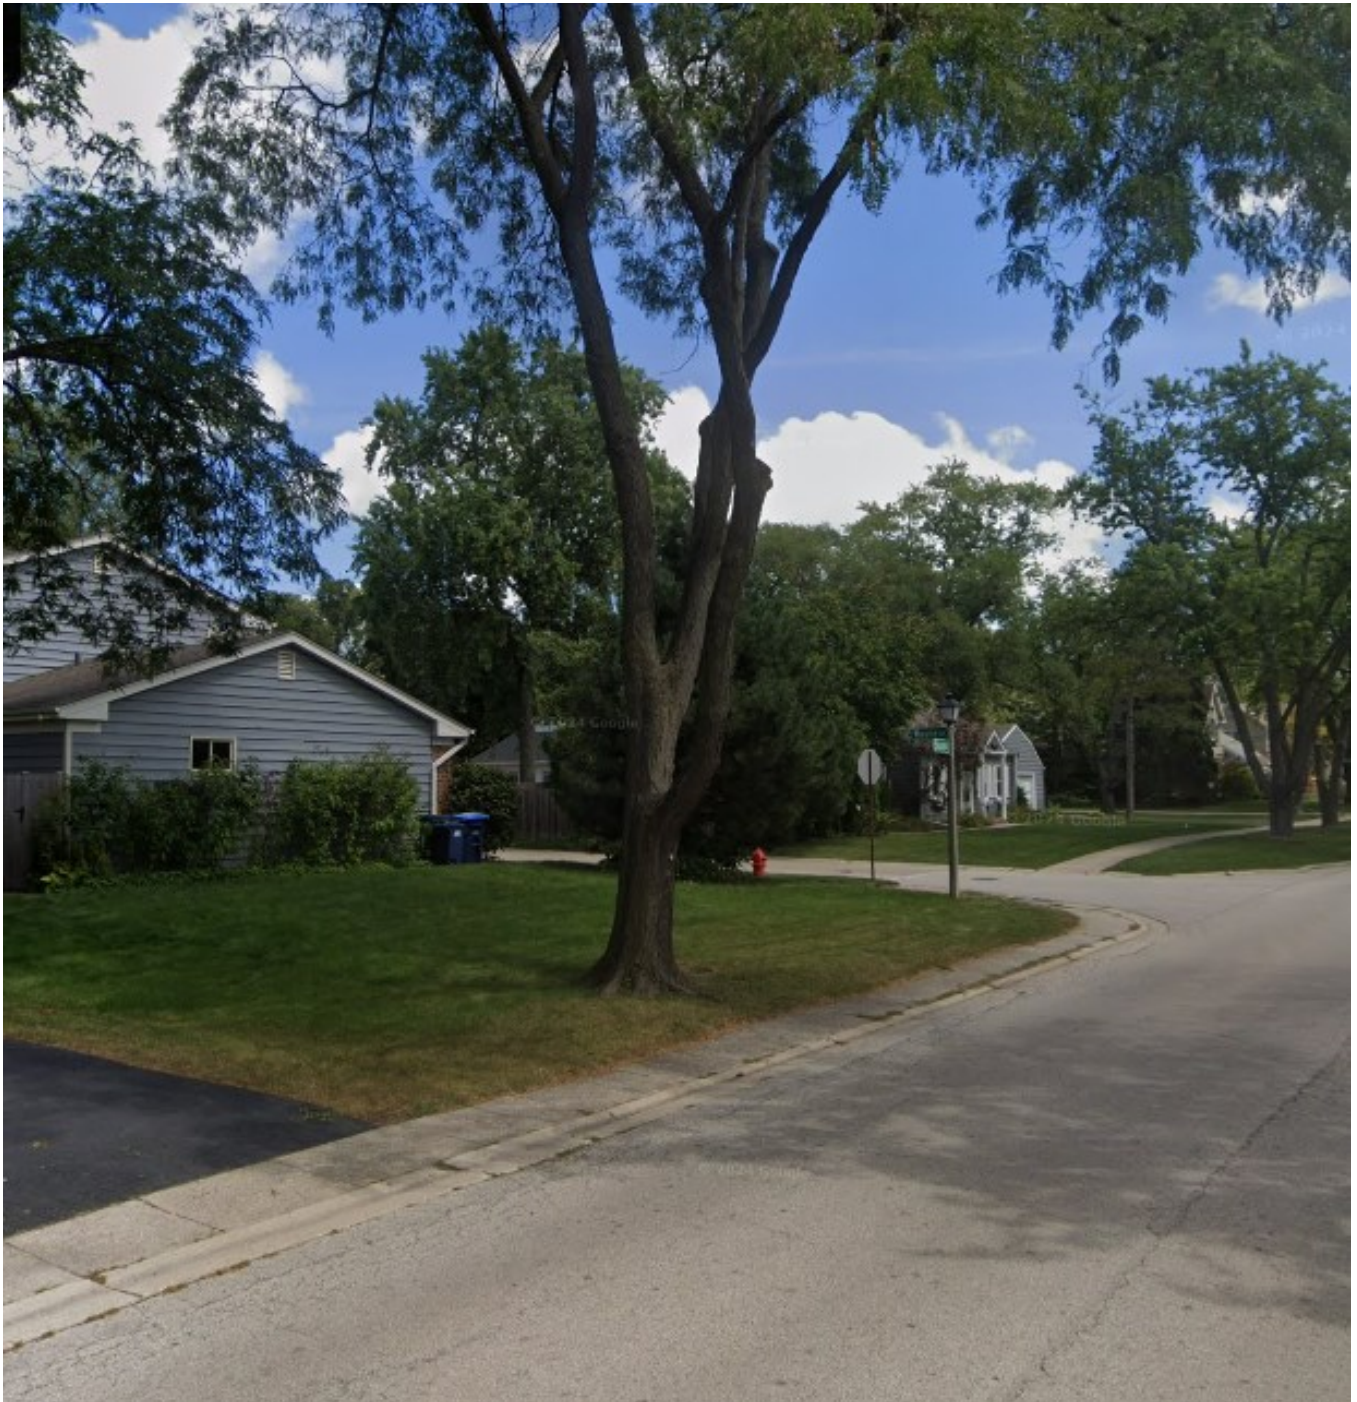
Tree	Address	Size	Species	Condition	Notes
19	1008 Wayne	25	Honey locust	3	Sidewalk work weak crotch, multiple leaders, sucker growth, broken branches

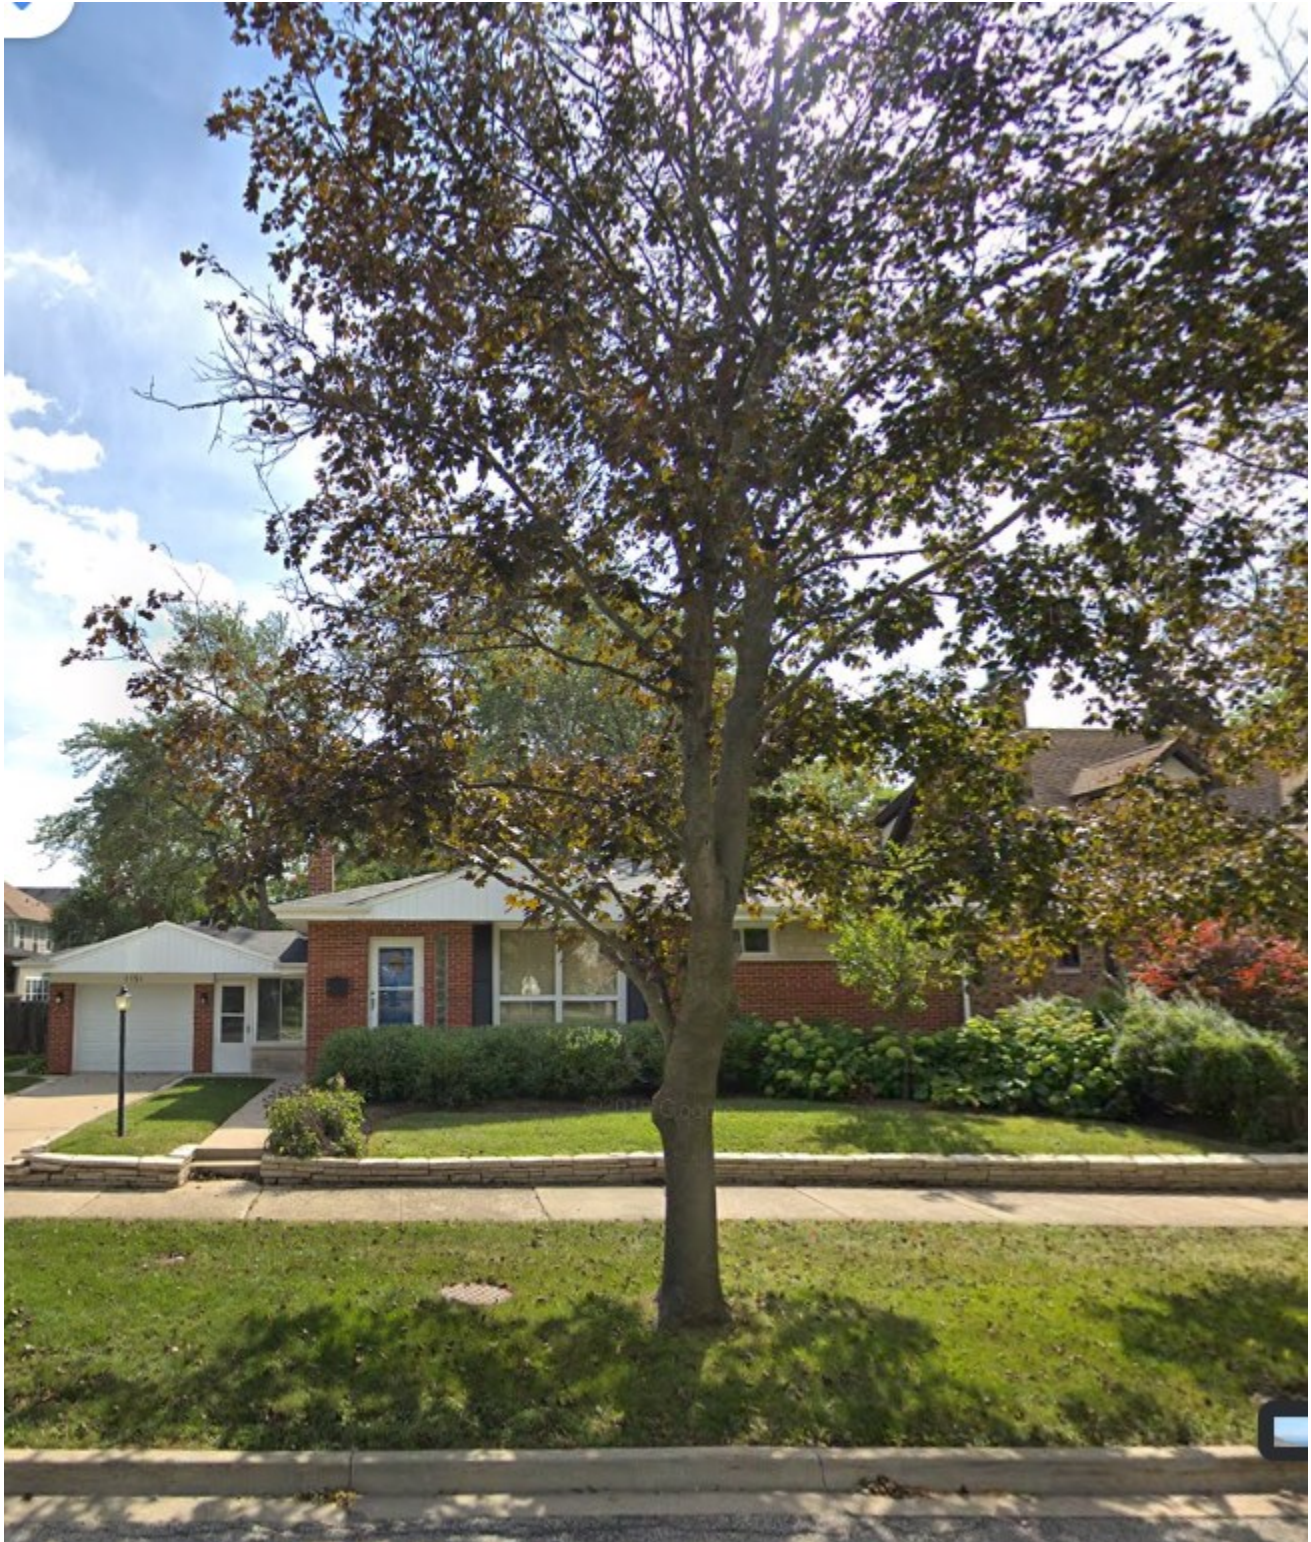
Tree	Address	Size	Species	Condition	Notes
20	1151 Hazel	16	Norway Maple	4	Storm sewer work trunk scar, weak crotch, decay, sucker growth

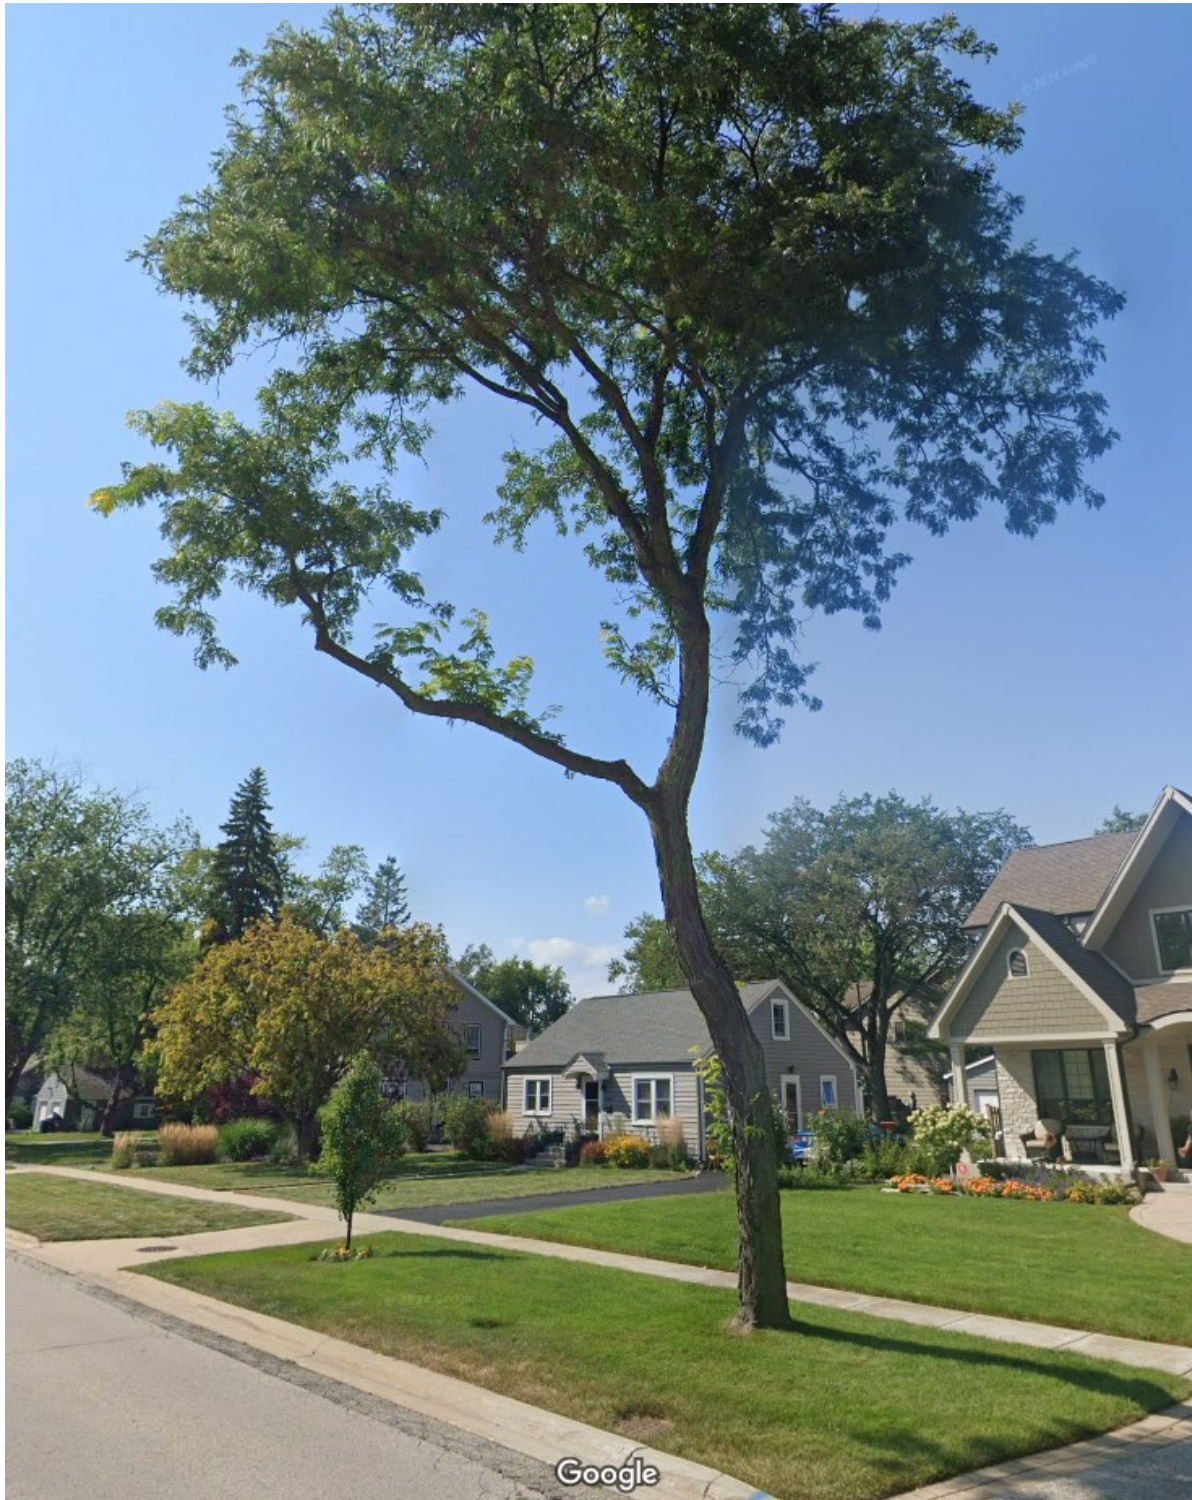
Tree	Address	Size	Species	Condition	Notes
21	1128 Hazel	16	Honey Locust	3	Storm sewer work? Twist in trunk, suckering, minor deadwood, multiple leaders

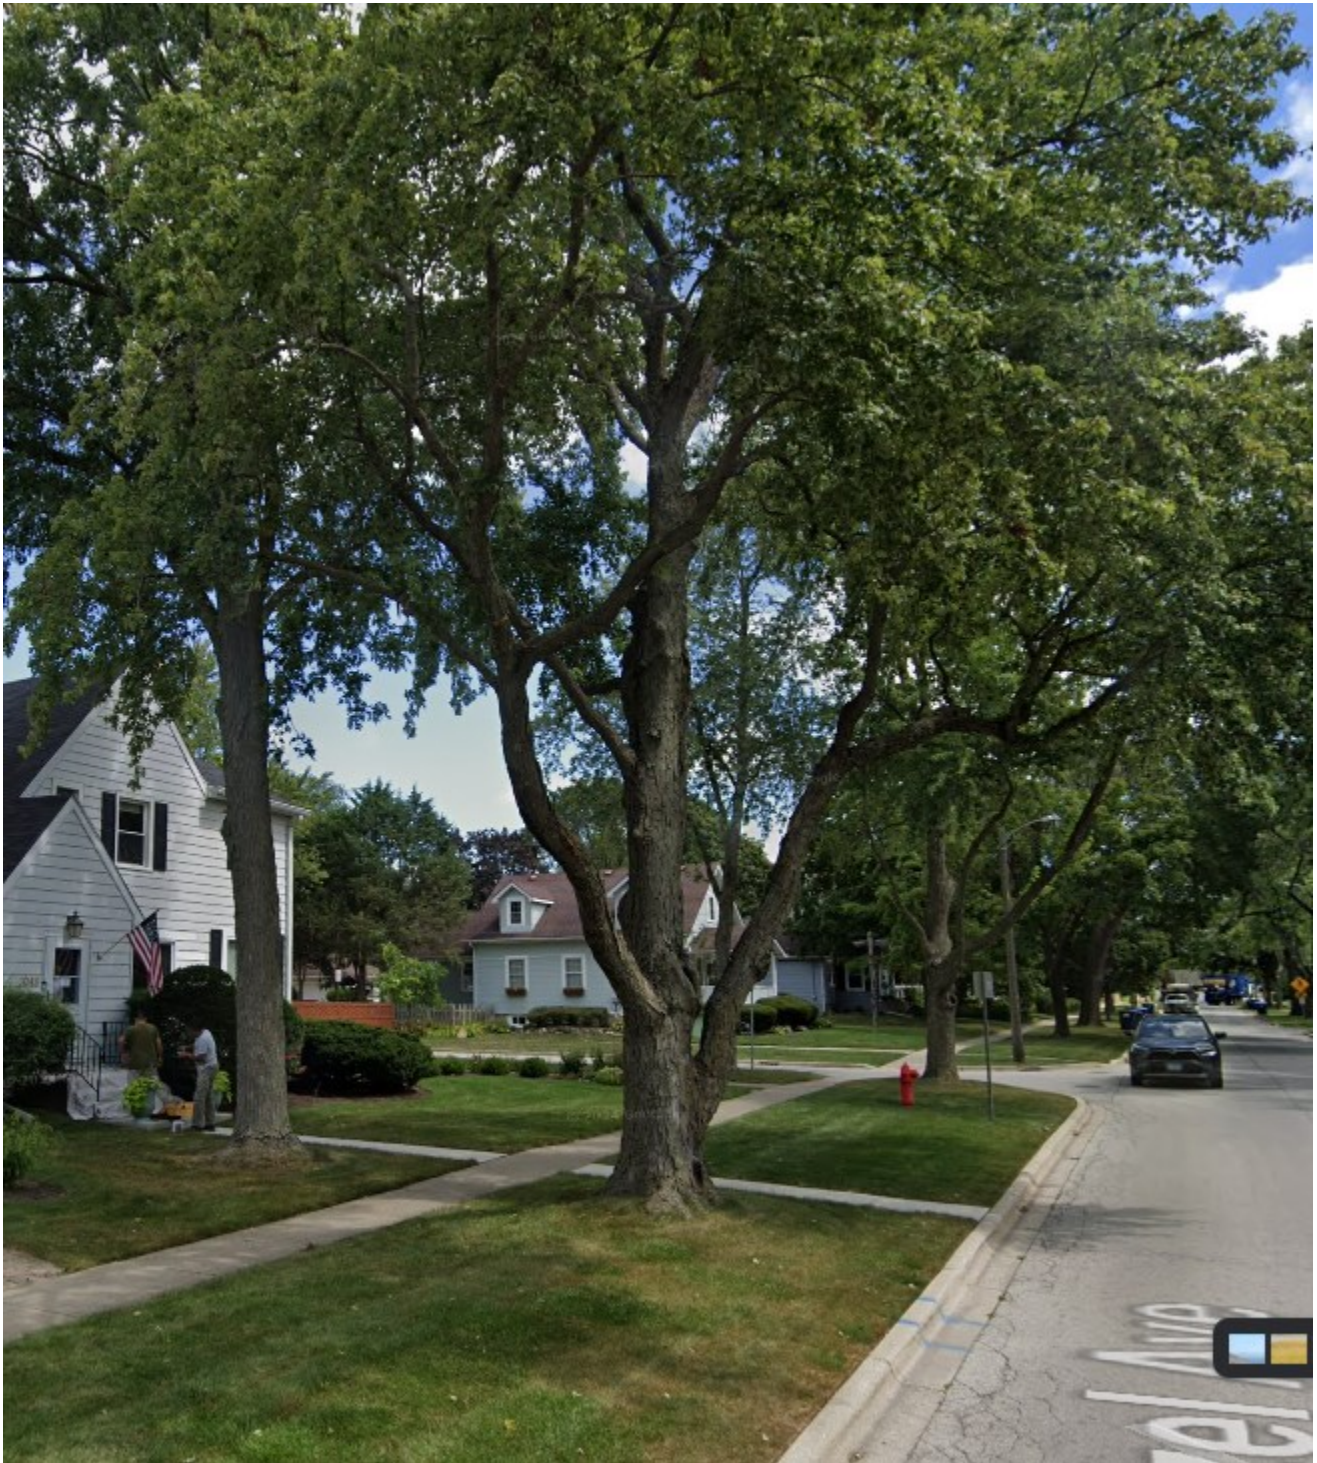
Tree	Address	Size	Species	Condition	Notes
22	1048 Hazel	32	Silver Maple	4	Storm sewer work? trunk scar, decay, weak crotch, broken branches, multiple leaders

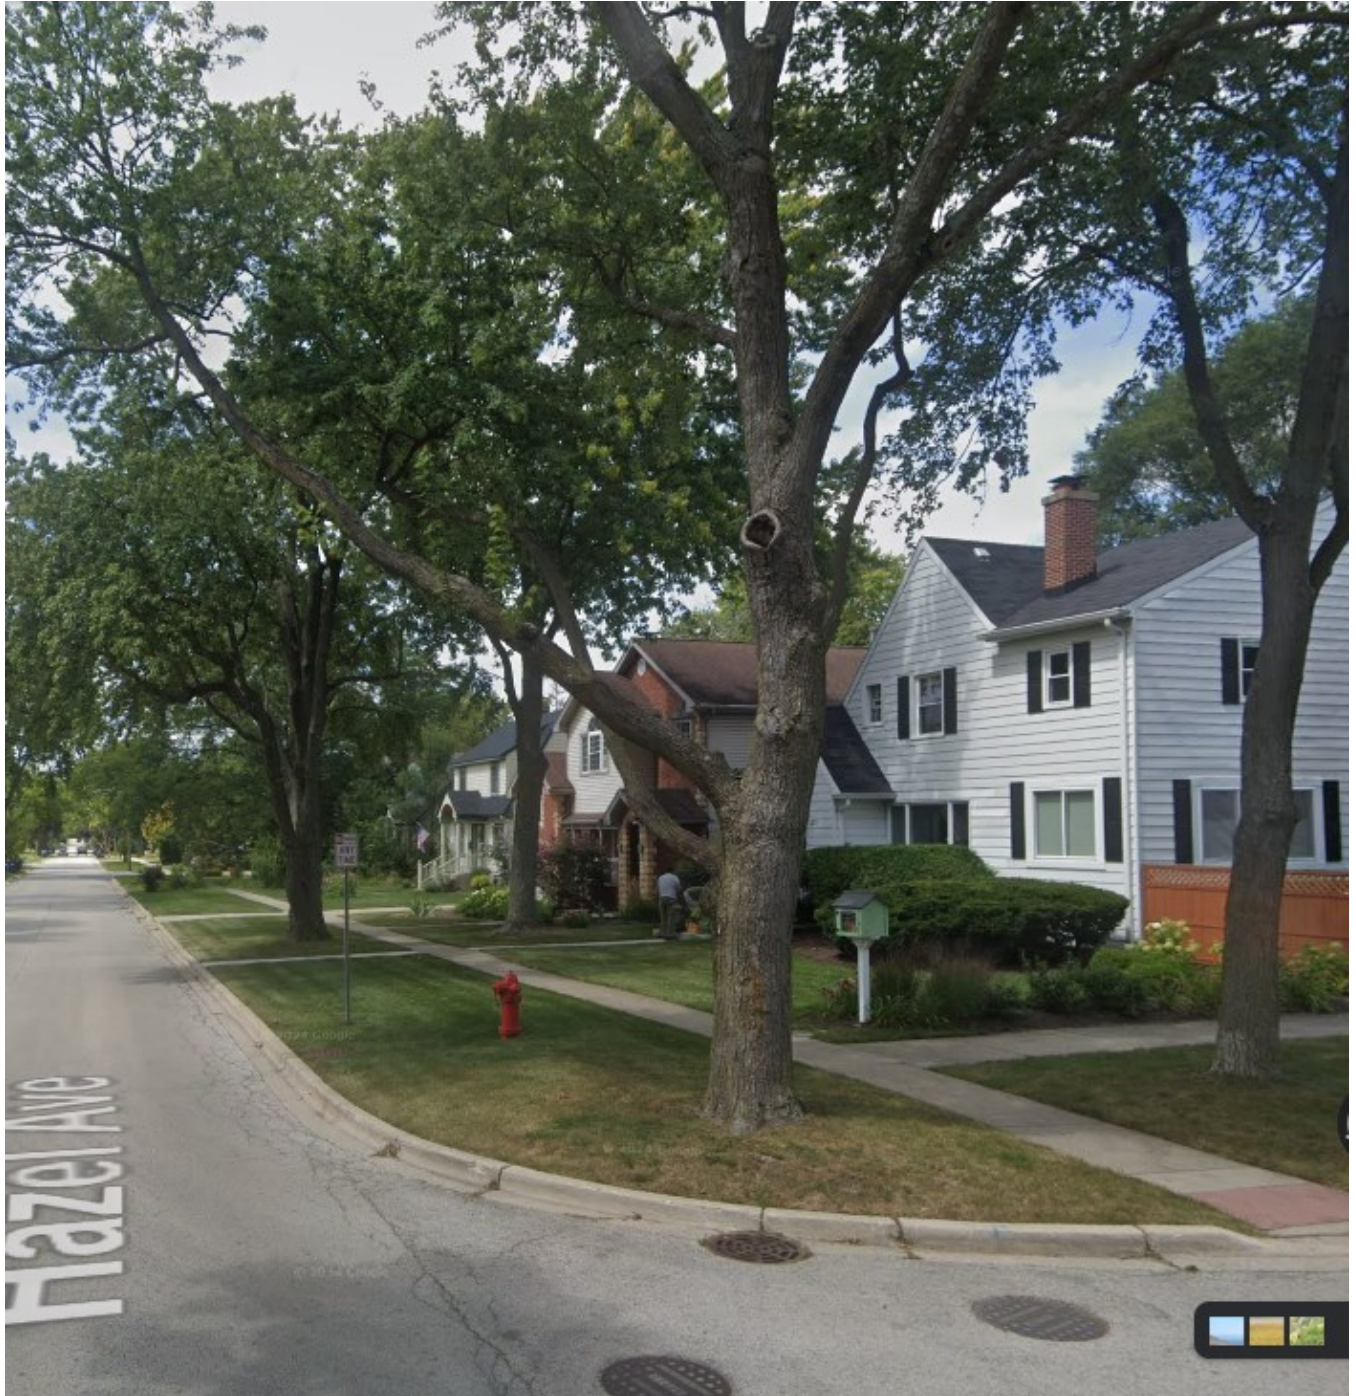
Tree	Address	Size	Species	Condition	Notes
23	1048 Hazel	23	Silver Maple	3	Storm sewer work? Multiple leaders, suckering, branch scars,

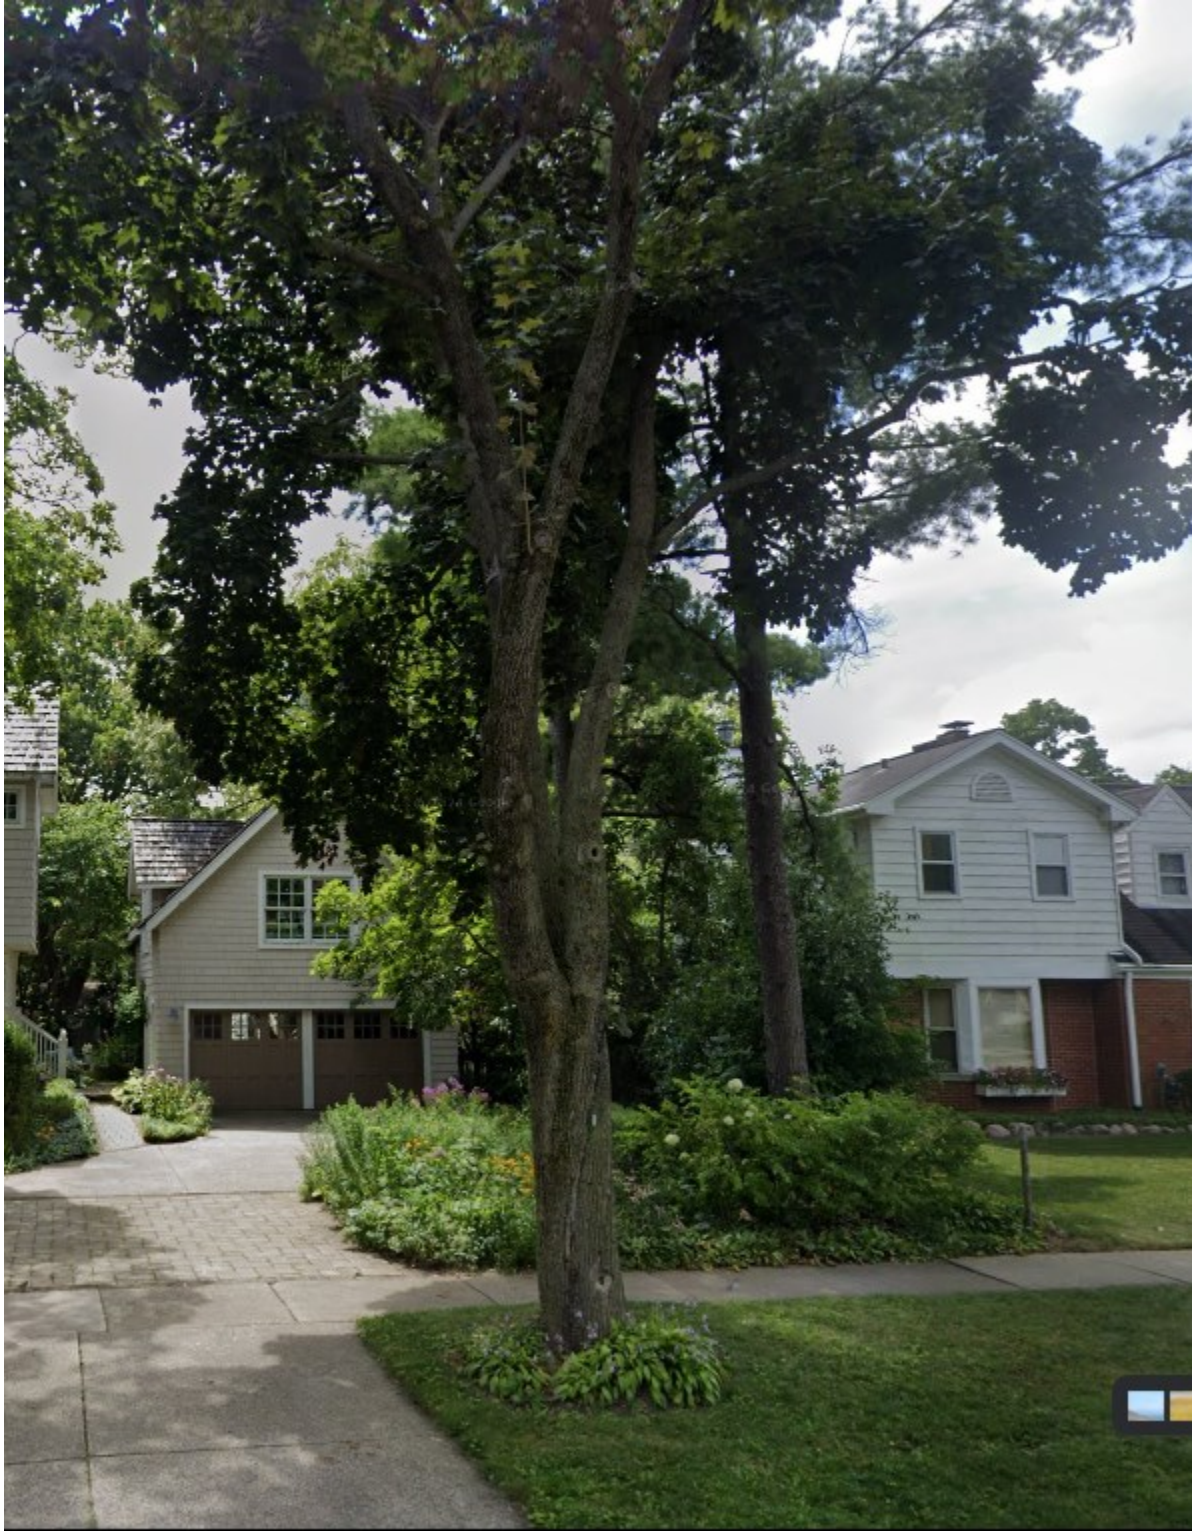
Tree	Address	Size	Species	Condition	Notes
24	1041 Hazel	19	Norway Maple	3	Driveway apron work/realignment girdling root, weak crotch, multiple leaders

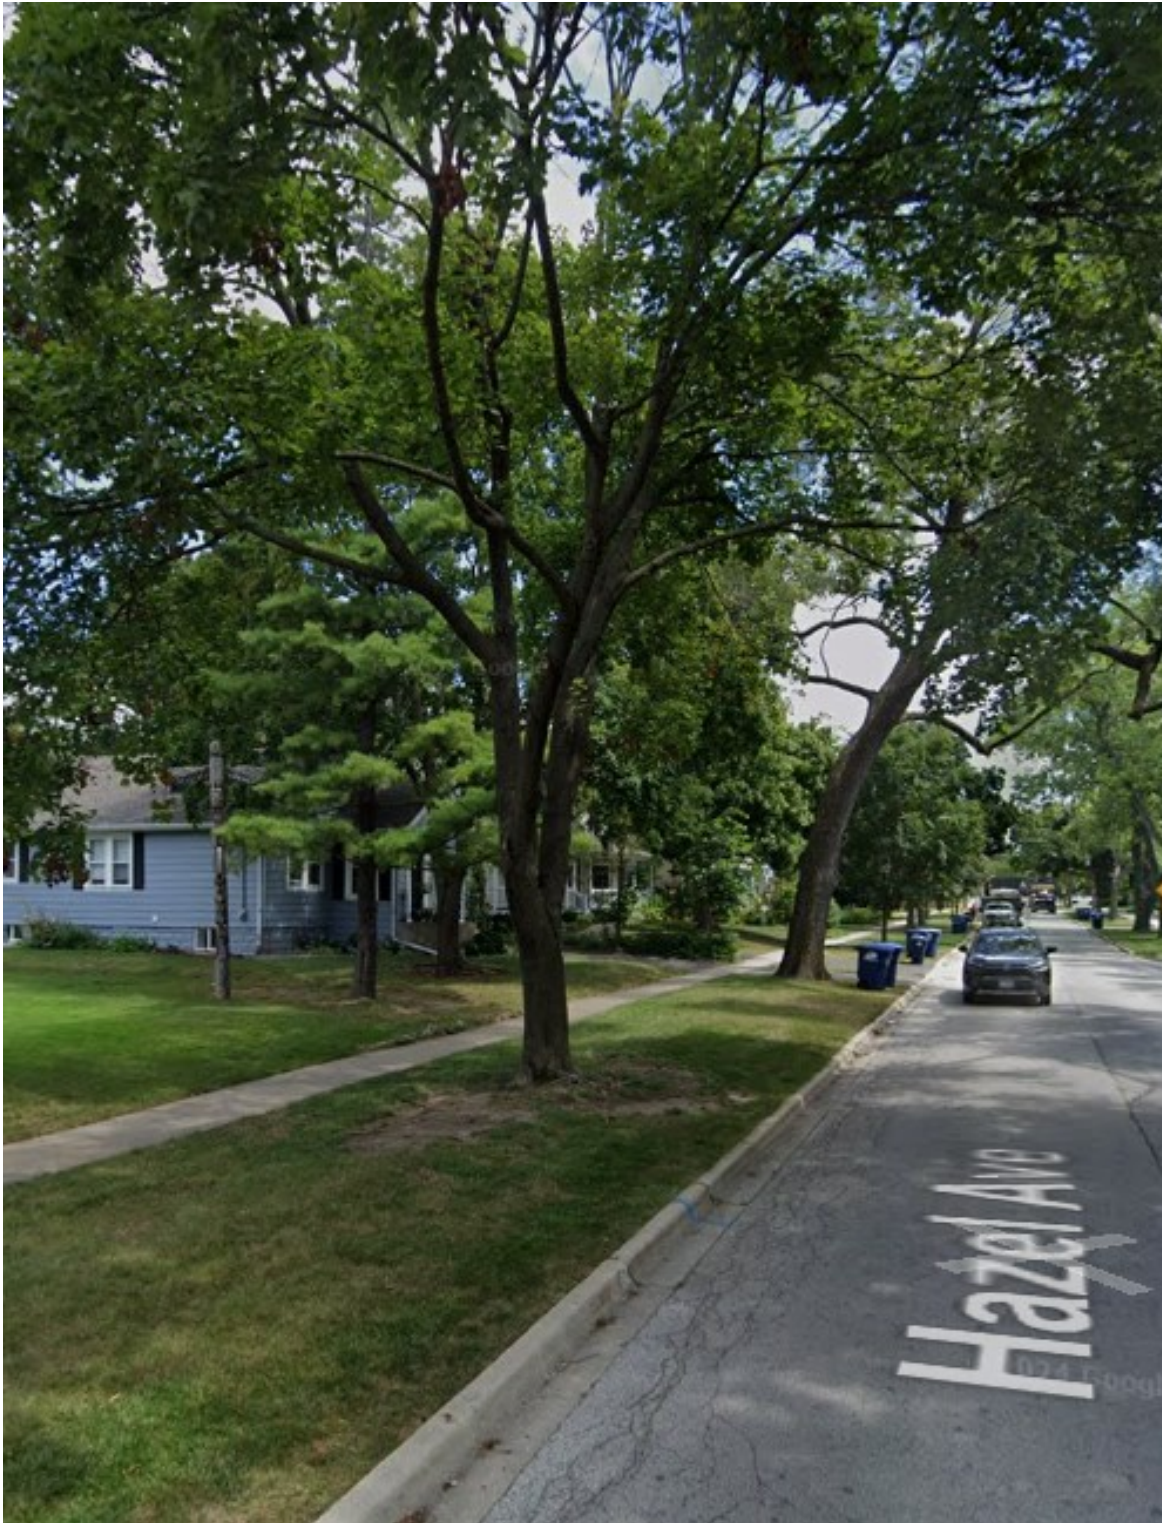
Tree	Address	Size	Species	Condition	Notes
25	1038 Hazel	19	Norway Maple	3	Storm sewer work? multiple leaders, sucker growth, girdling root

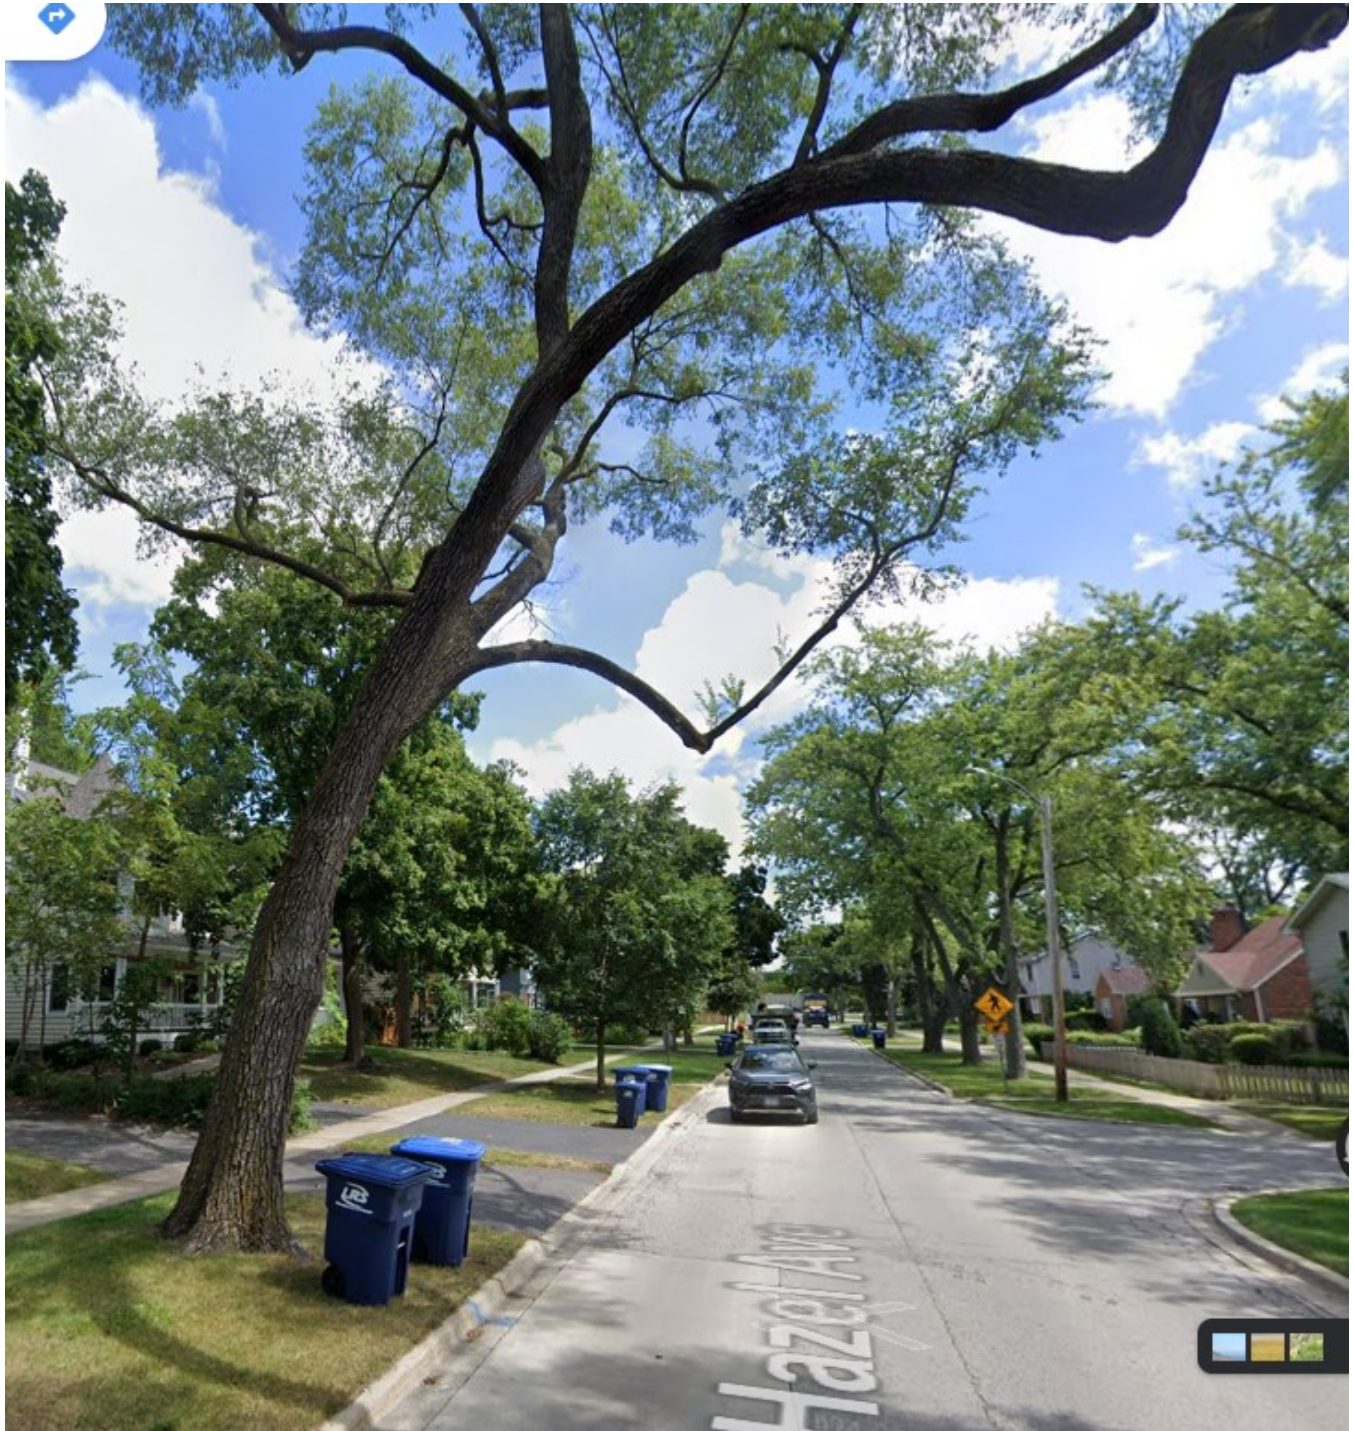
Tree	Address	Size	Species	Condition	Notes
26	1030 Hazel	32	Siberian Elm	3	Storm sewer work? Lean weak crotch, slight sweep, minor deadwood, multiple leaders
